Monitoring Plan for No Augmentation

Background

Analysis of Augmentation 2017-2022

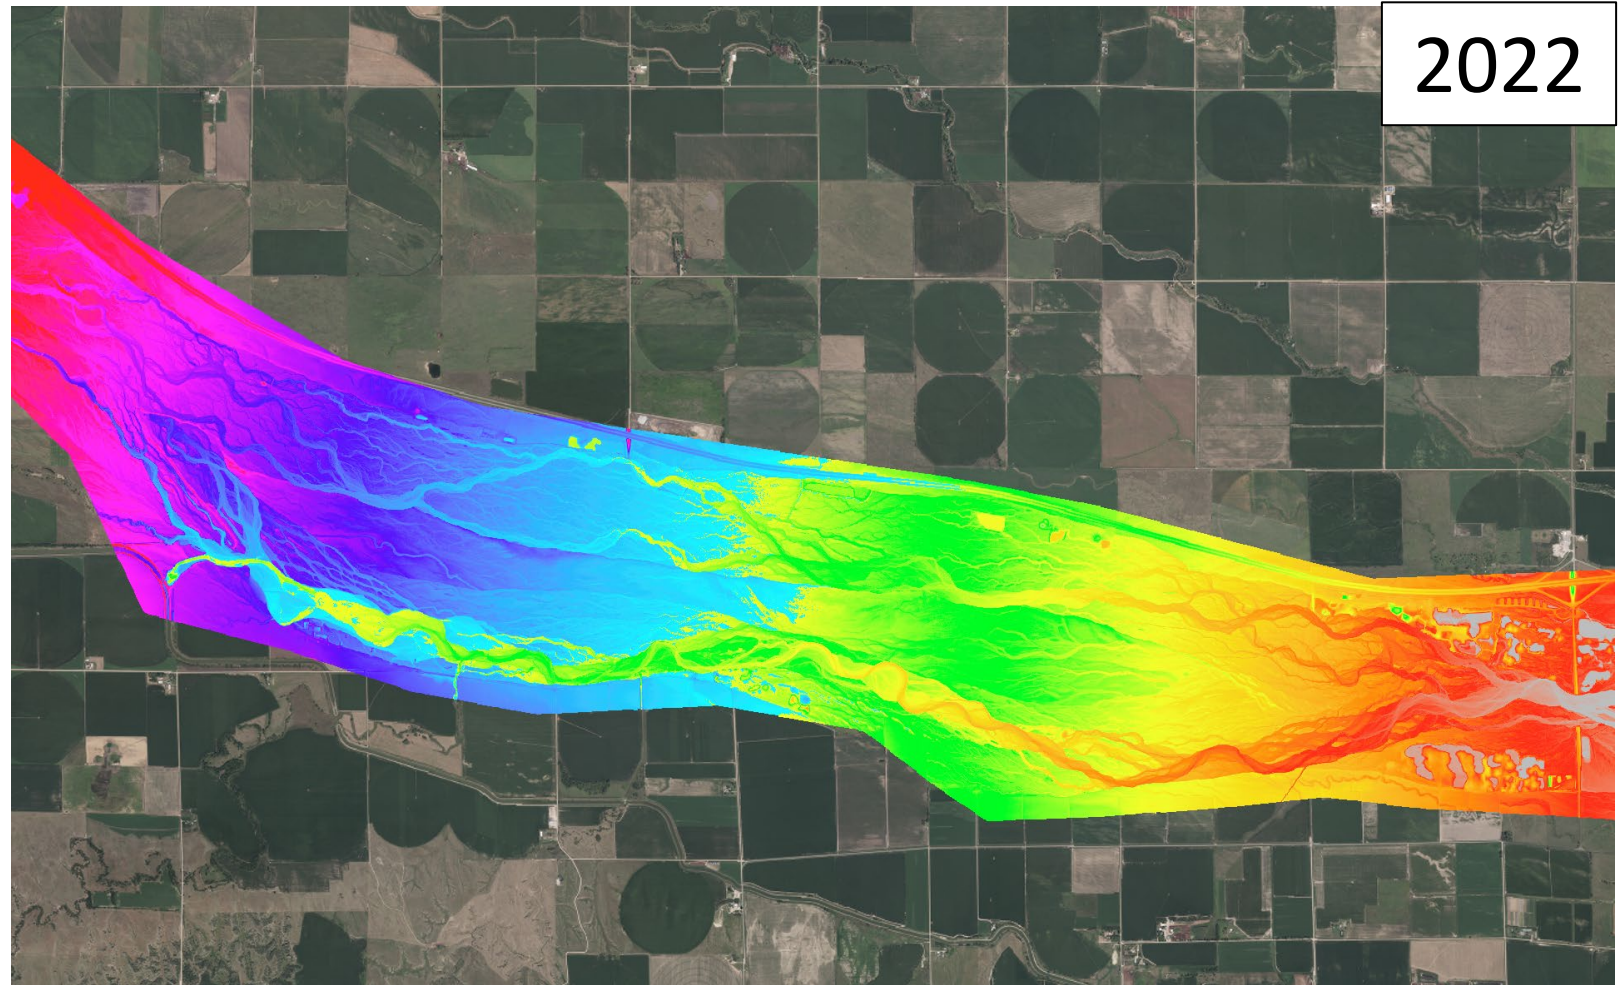
- Annual Aerial Imagery
- Annual Topobathymetric LiDAR

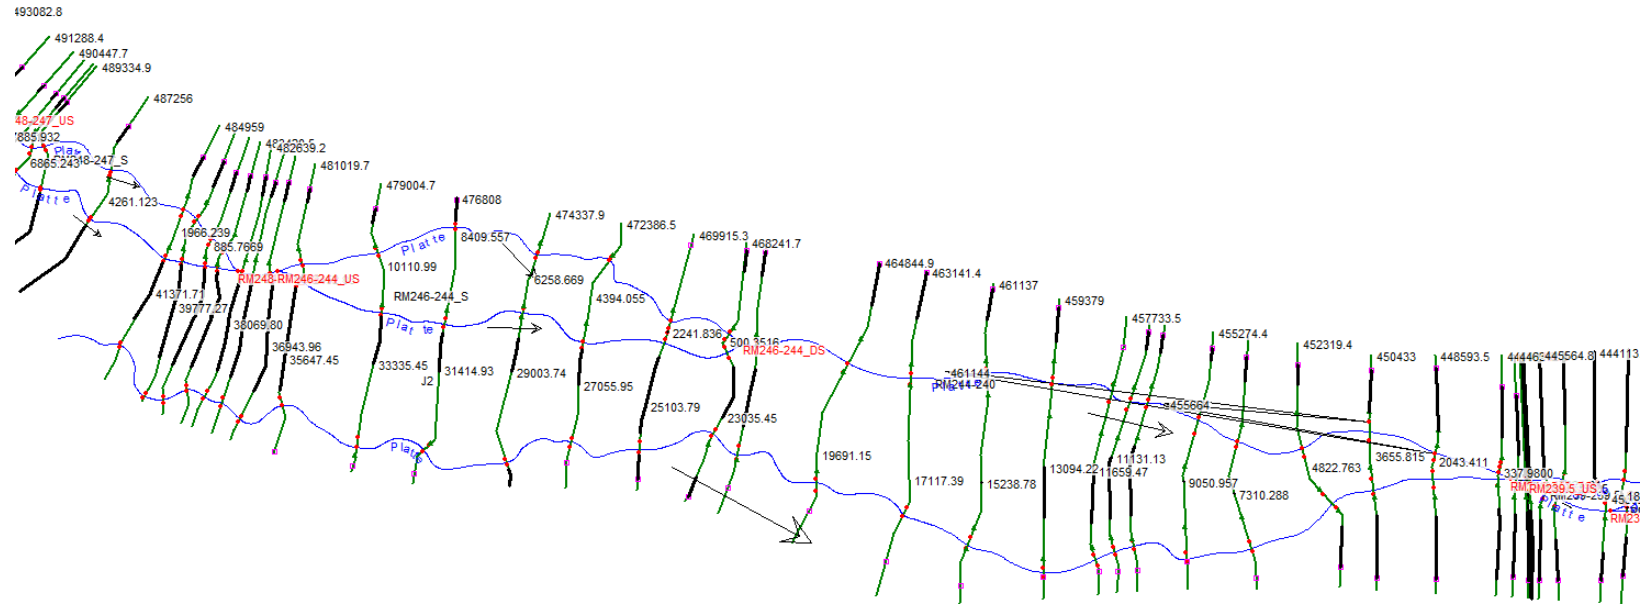
- Annual Aerial Imagery
- Annual Topobathymetric LiDAR
- Stream Gage Records
- Historical Transects
- Historical Aerial Imagery
- 2009 1D HEC-RAS Model

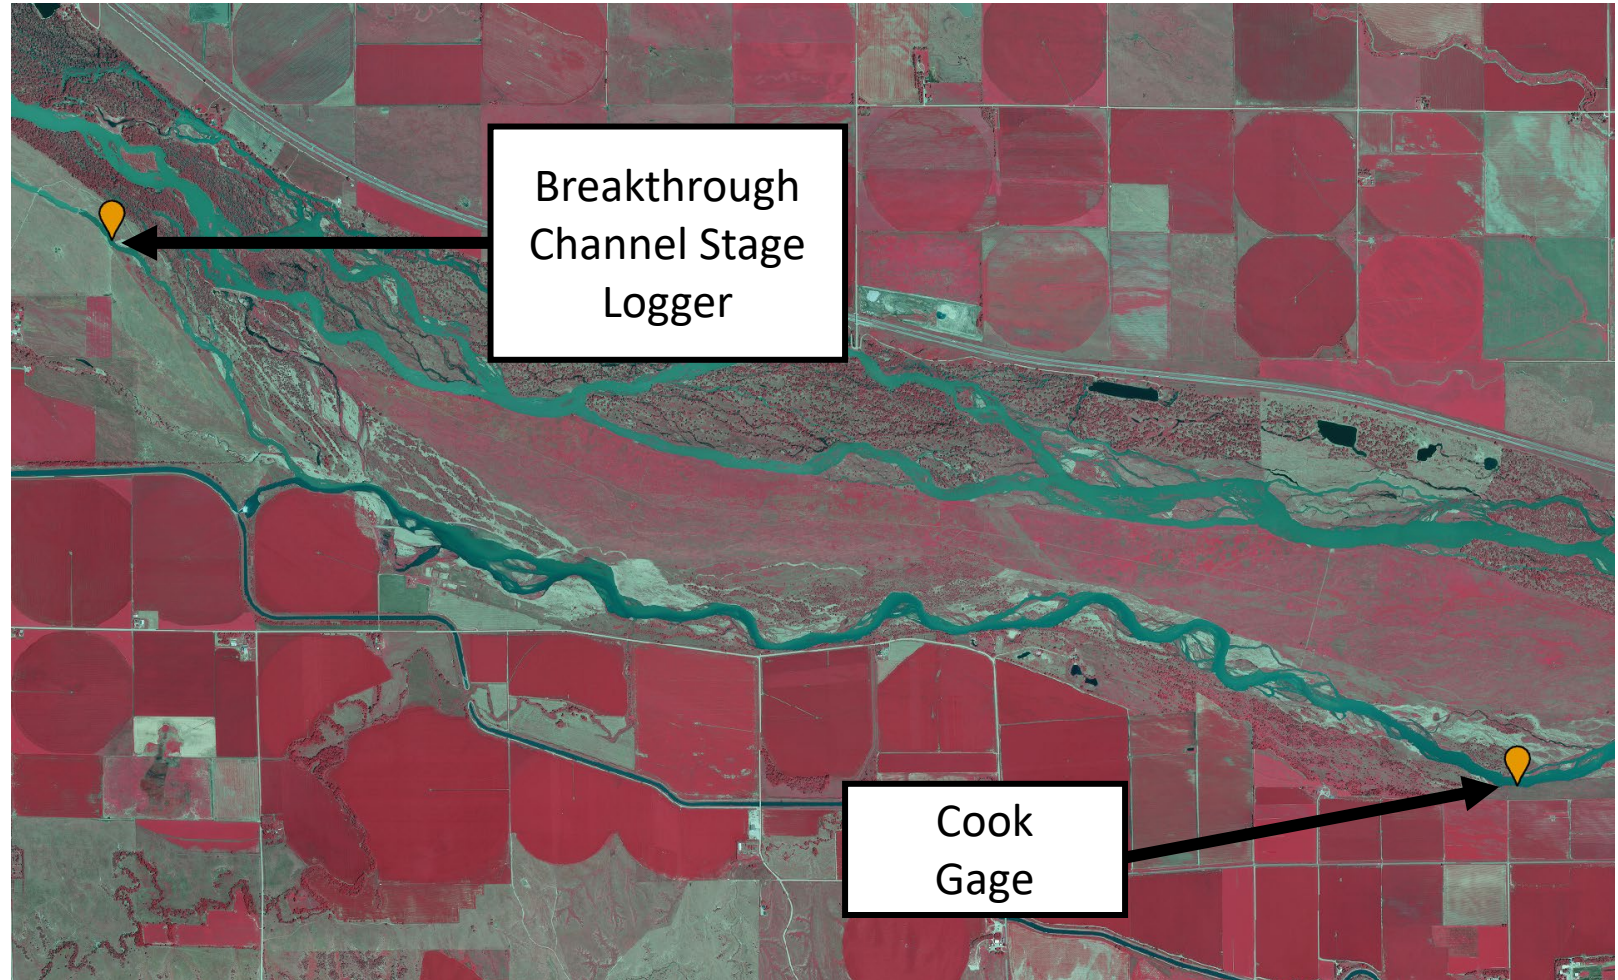
New Data Collection – Flow Monitoring

- Breakthrough channel
 - Stage logger
- Cook Property
 - Real time stream gage
 - USGS managed

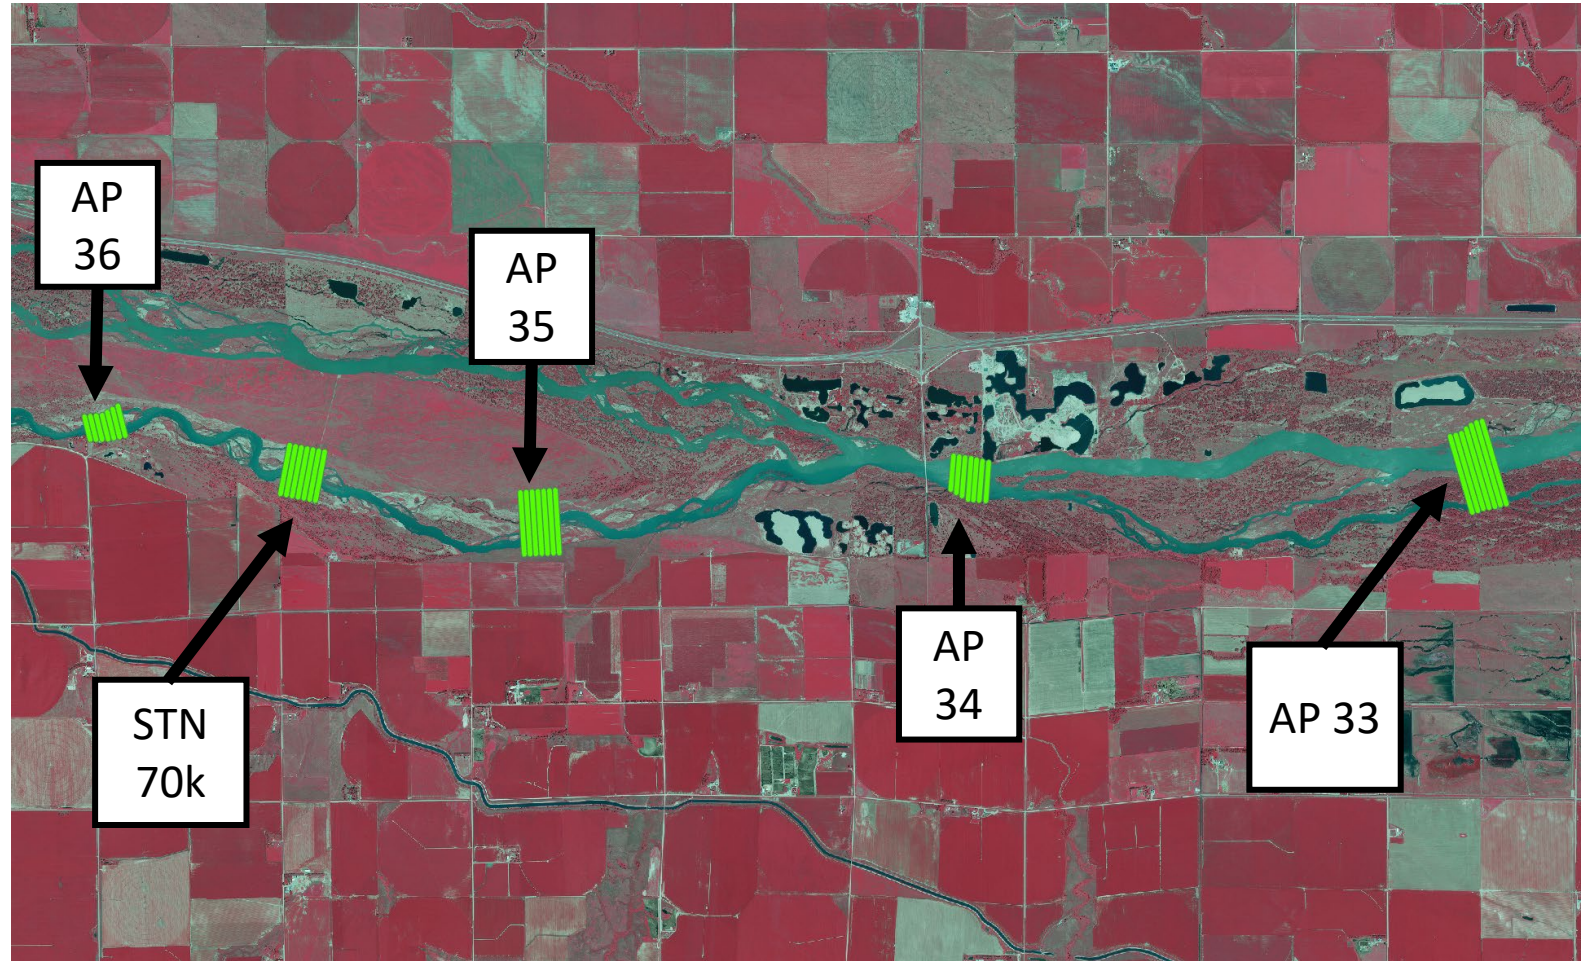
New Data Collection – Cross Section Surveys

- Tied into 4 anchor points and station 70k
 - 7 cross section surveys at each
- Tri-annual data collection
 - March
 - July
 - November

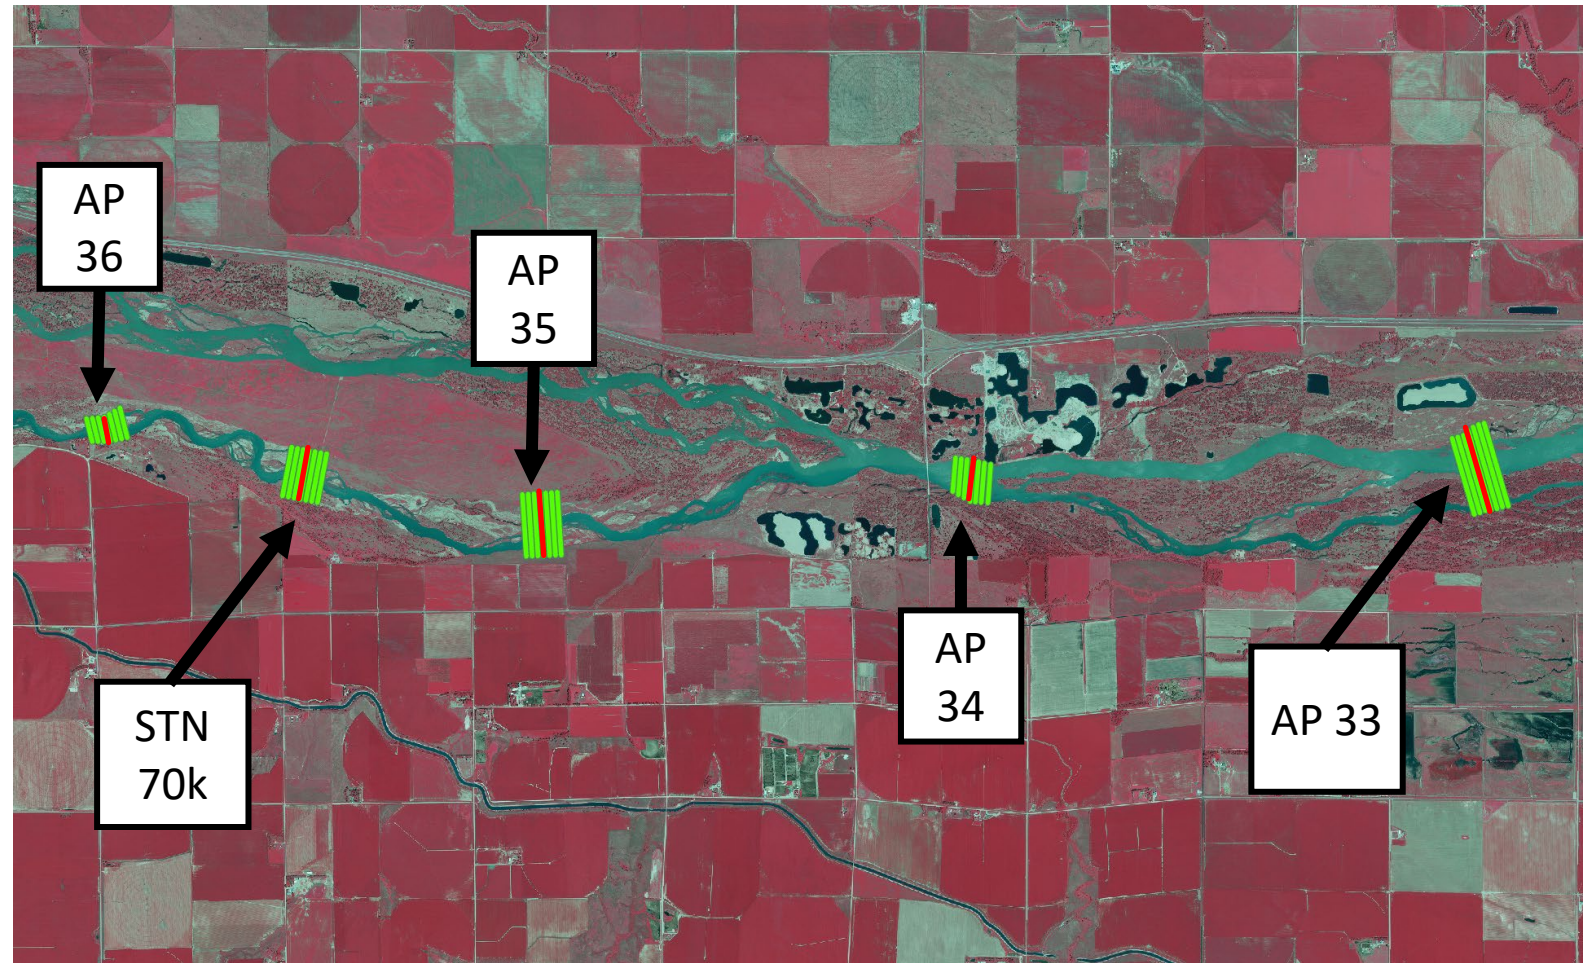
New Data Collection – Sediment Sampling

- Done concurrently with one annual transect survey
 - 3 samples at middle cross section
 - 15 total
- Sampling thalweg, channel left, and channel right

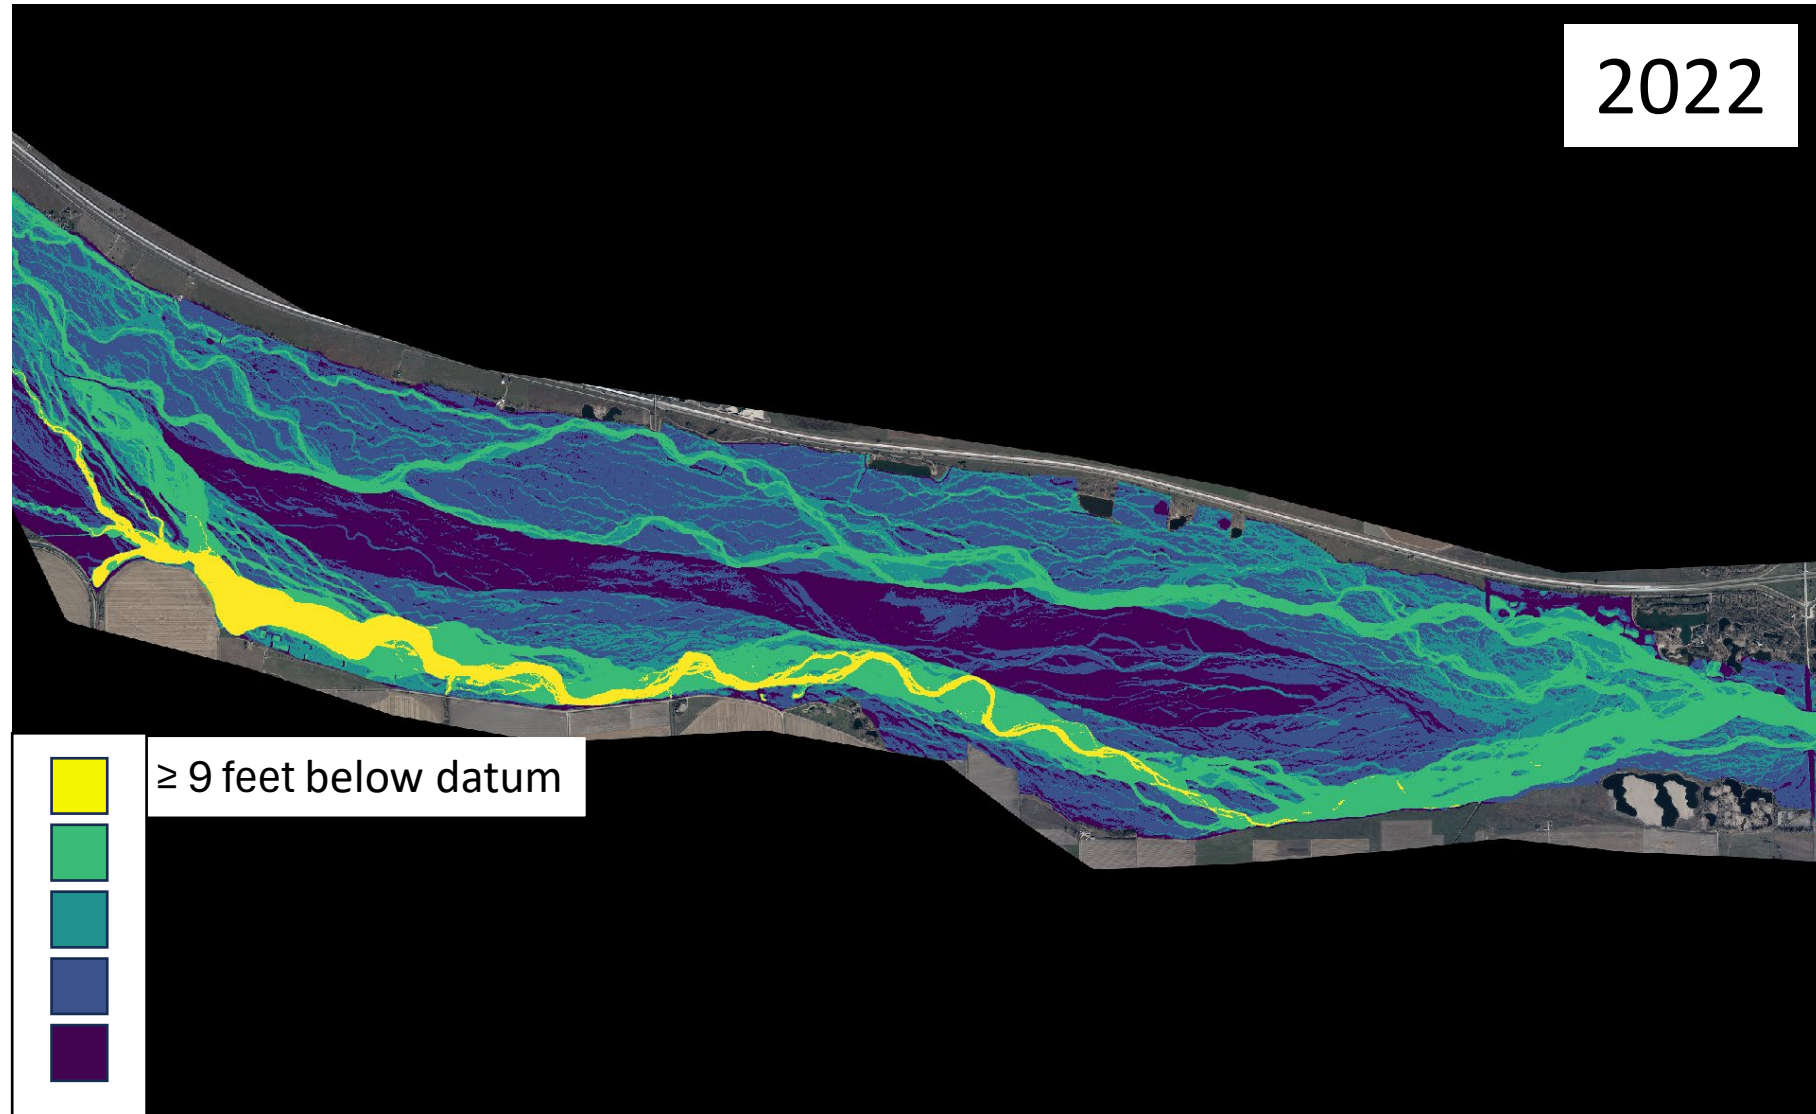
REM Refresh

- Geomorphic grade line (GGL) provides a datum
- Annual LiDAR is compared against GGL
- Creates an REM that represents depth below geomorphic grade line (DBG)

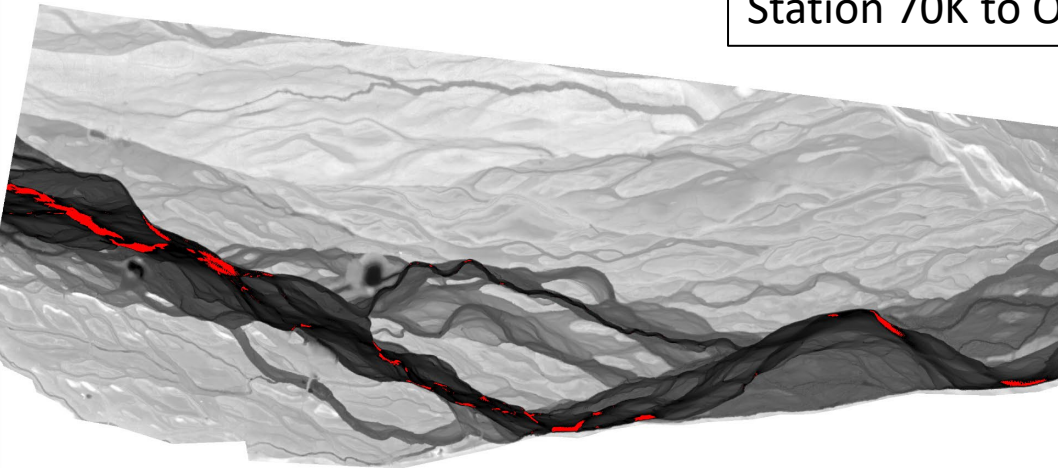
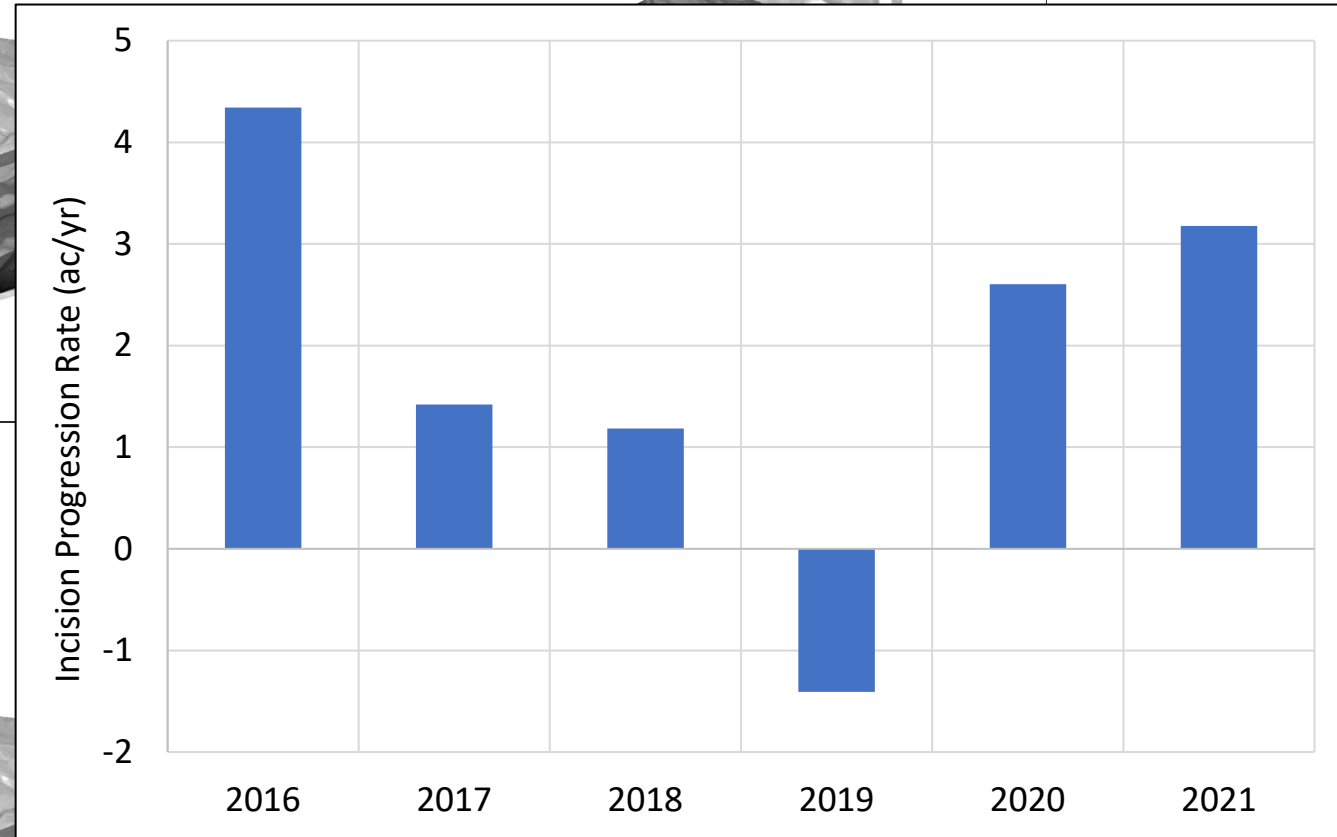
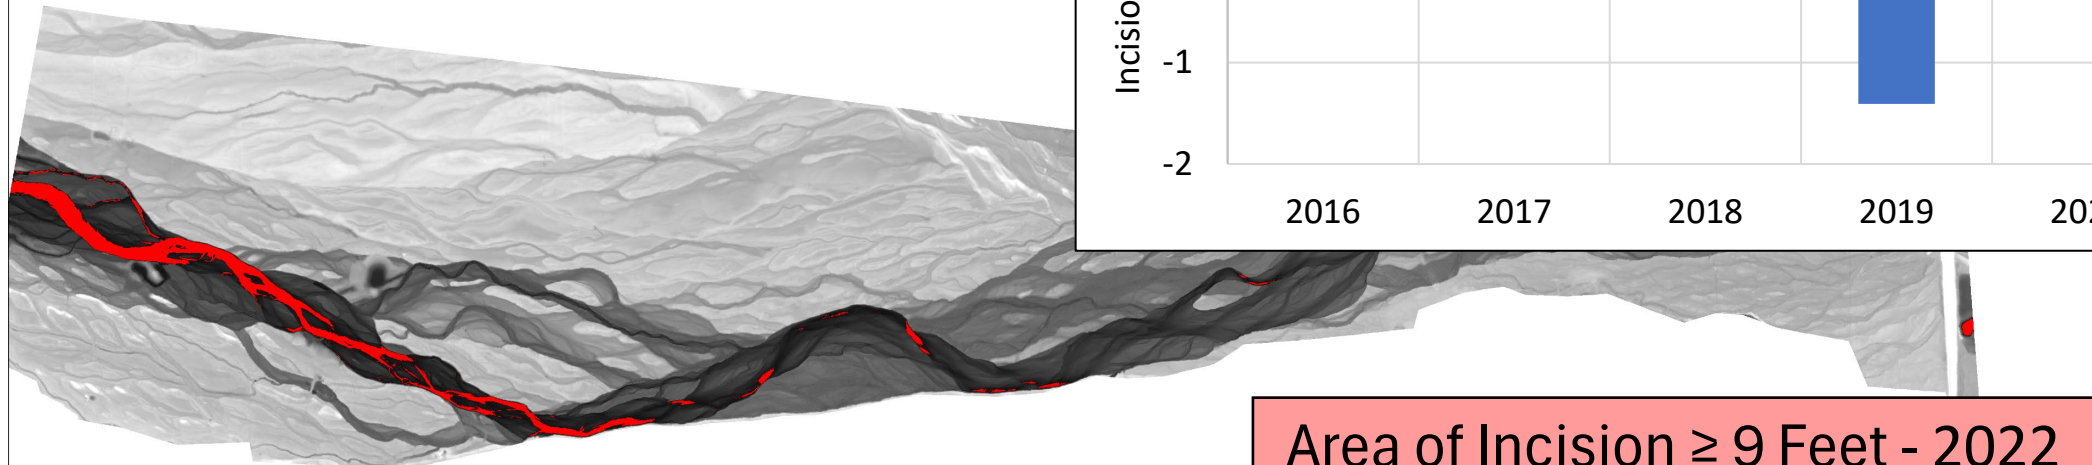
Year to Year Comparison: AOI-1

Station 70K to Overton Bridge

Max Annual Increase: 4.34 acres
Average Annual Increase: 1.89 acres

Area of Incision \geq 9 Feet - 2022

Impact Trigger Level	Description	Response
Normal	Observed area with DBG ≥ 9 ft remained below 10 acres over a year	Maintain monitoring efforts: No change to surveys or REM method.
Warning	Observed area with DBG ≥ 9 ft exceeded 10 acres over a year for the first time	Be on alert for year two, notify TAC of exceedance.
Action Required	Observed area with DBG ≥ 9 ft increased by more than 10 acres for a second consecutive year	Discuss modifications to experiment: Potentially restart augmentation

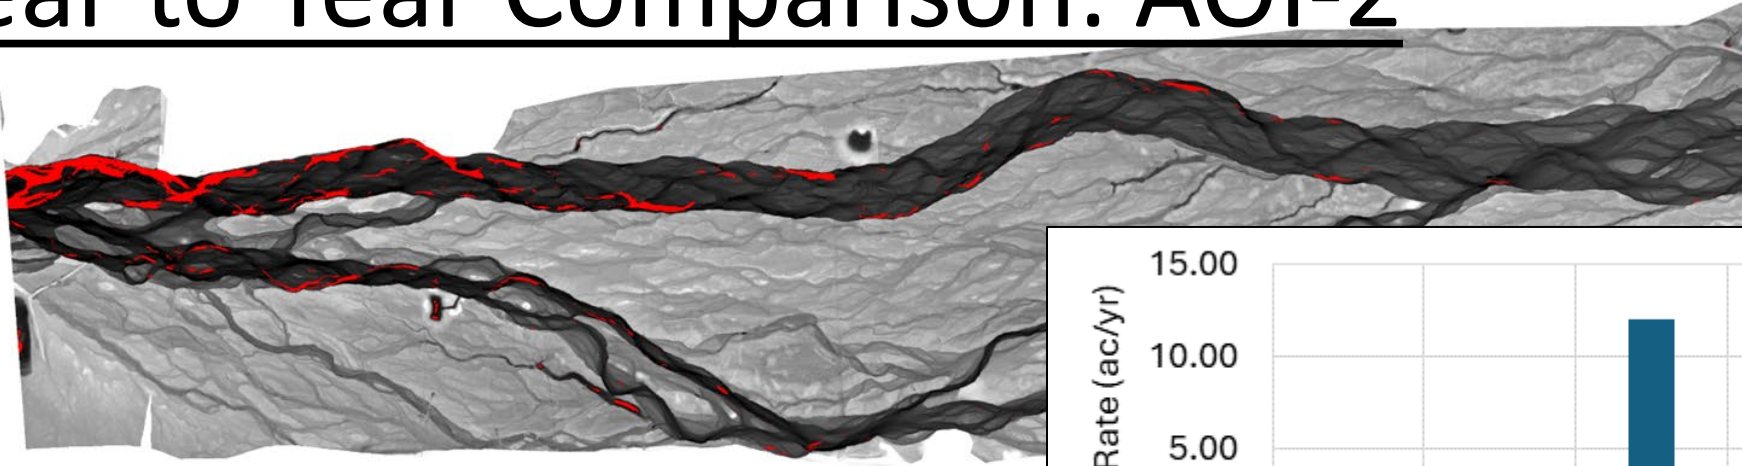
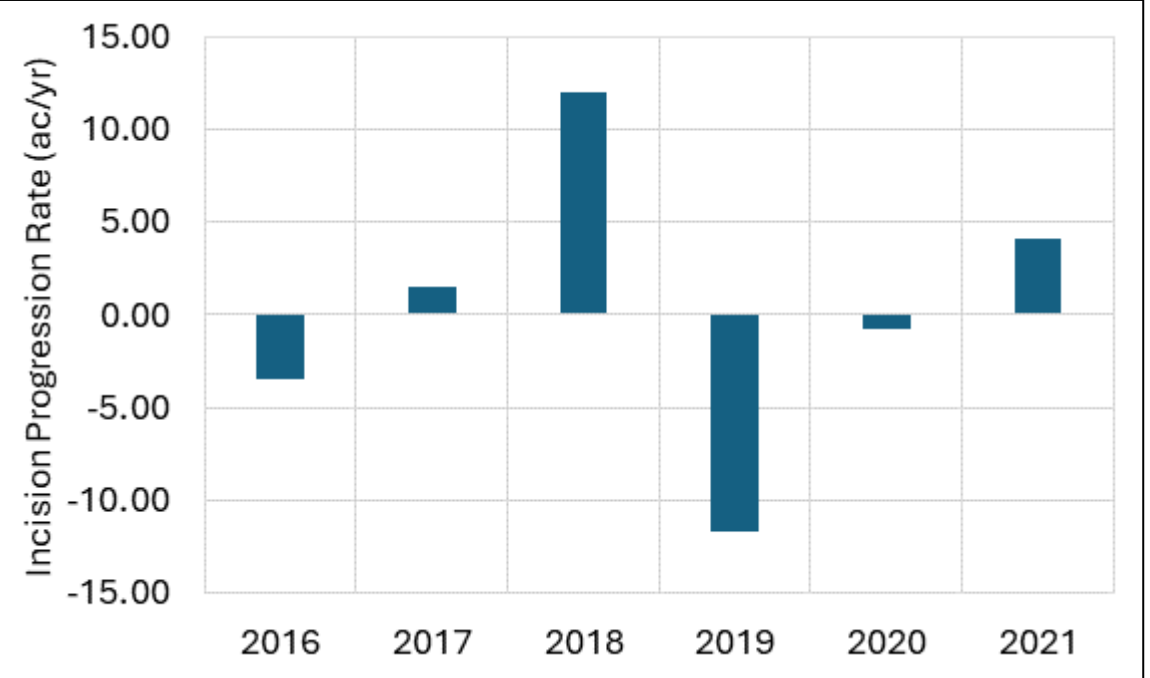
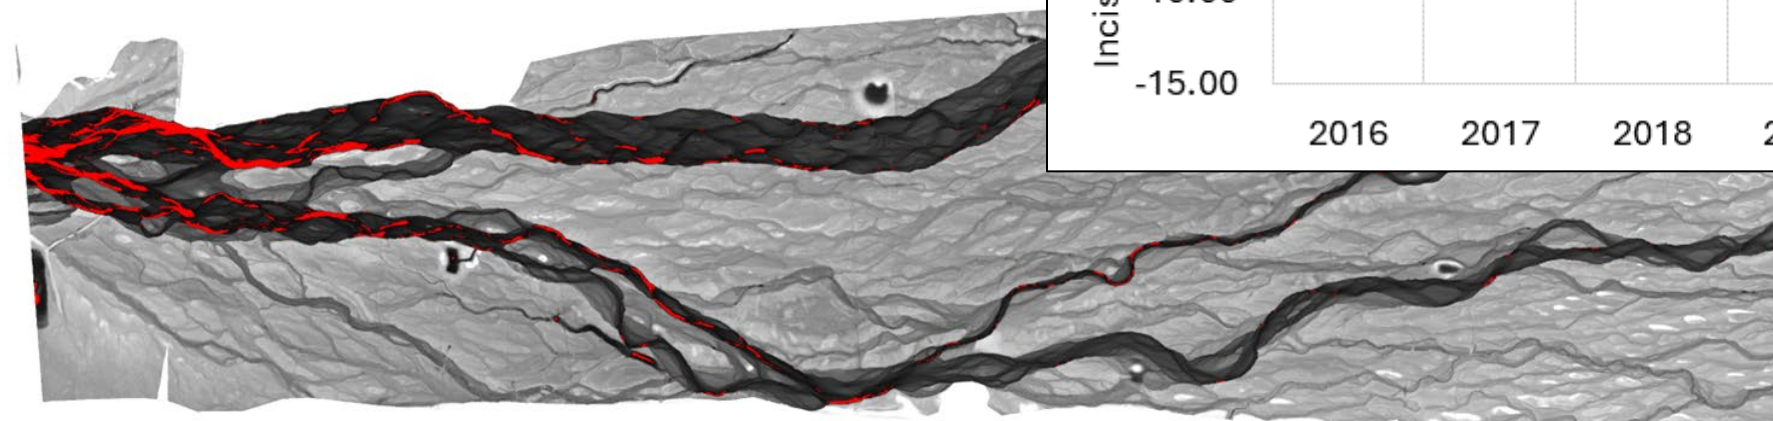
Year to Year Comparison: AOI-2

Max Annual Increase: 11.96 acres
Average Annual Increase: 0.27 acres

Overton Bridge to Cottonwood Ranch

Area of Incision \geq 5 Feet - 2022

Impact Trigger Level	Description	Response
Normal	Observed area with DBG ≥ 5 ft remained below 24 acres over a year	Maintain monitoring efforts: No change to surveys or REM method.
Warning	Observed area with DBG ≥ 5 ft exceeded 24 acres over a year <i>for the first time</i>	Be on alert for year two, notify TAC of exceedance.
Action Required	Observed area with DBG ≥ 5 ft increased by more than 24 acres for a second consecutive year	Discuss modifications to experiment: Potentially restart augmentation

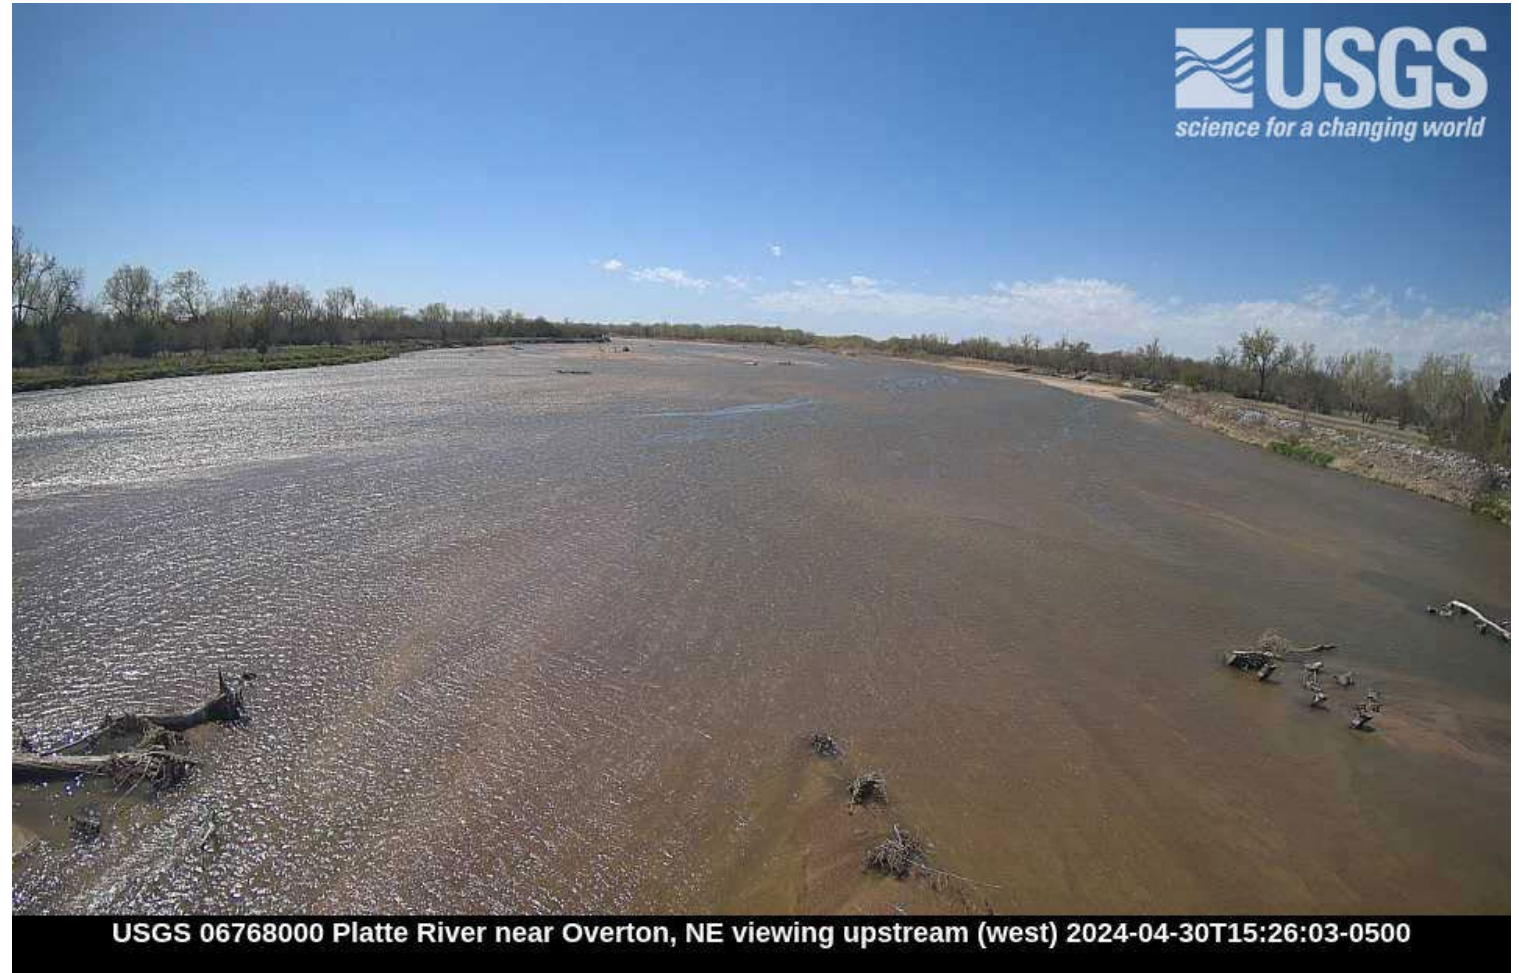
Gage Analysis

- 2012 Pilot Study
 - Water Surface Elevations
- 30+ years of Data at Overton
- Focus on changes at base flow
 - ~244 CFS
- Open to input!
