Cottonwood Ranch Broad-Scale Recharge

WAC Meeting

10/27/2020

Full-Scale Sediment Augmentation - UPDATE

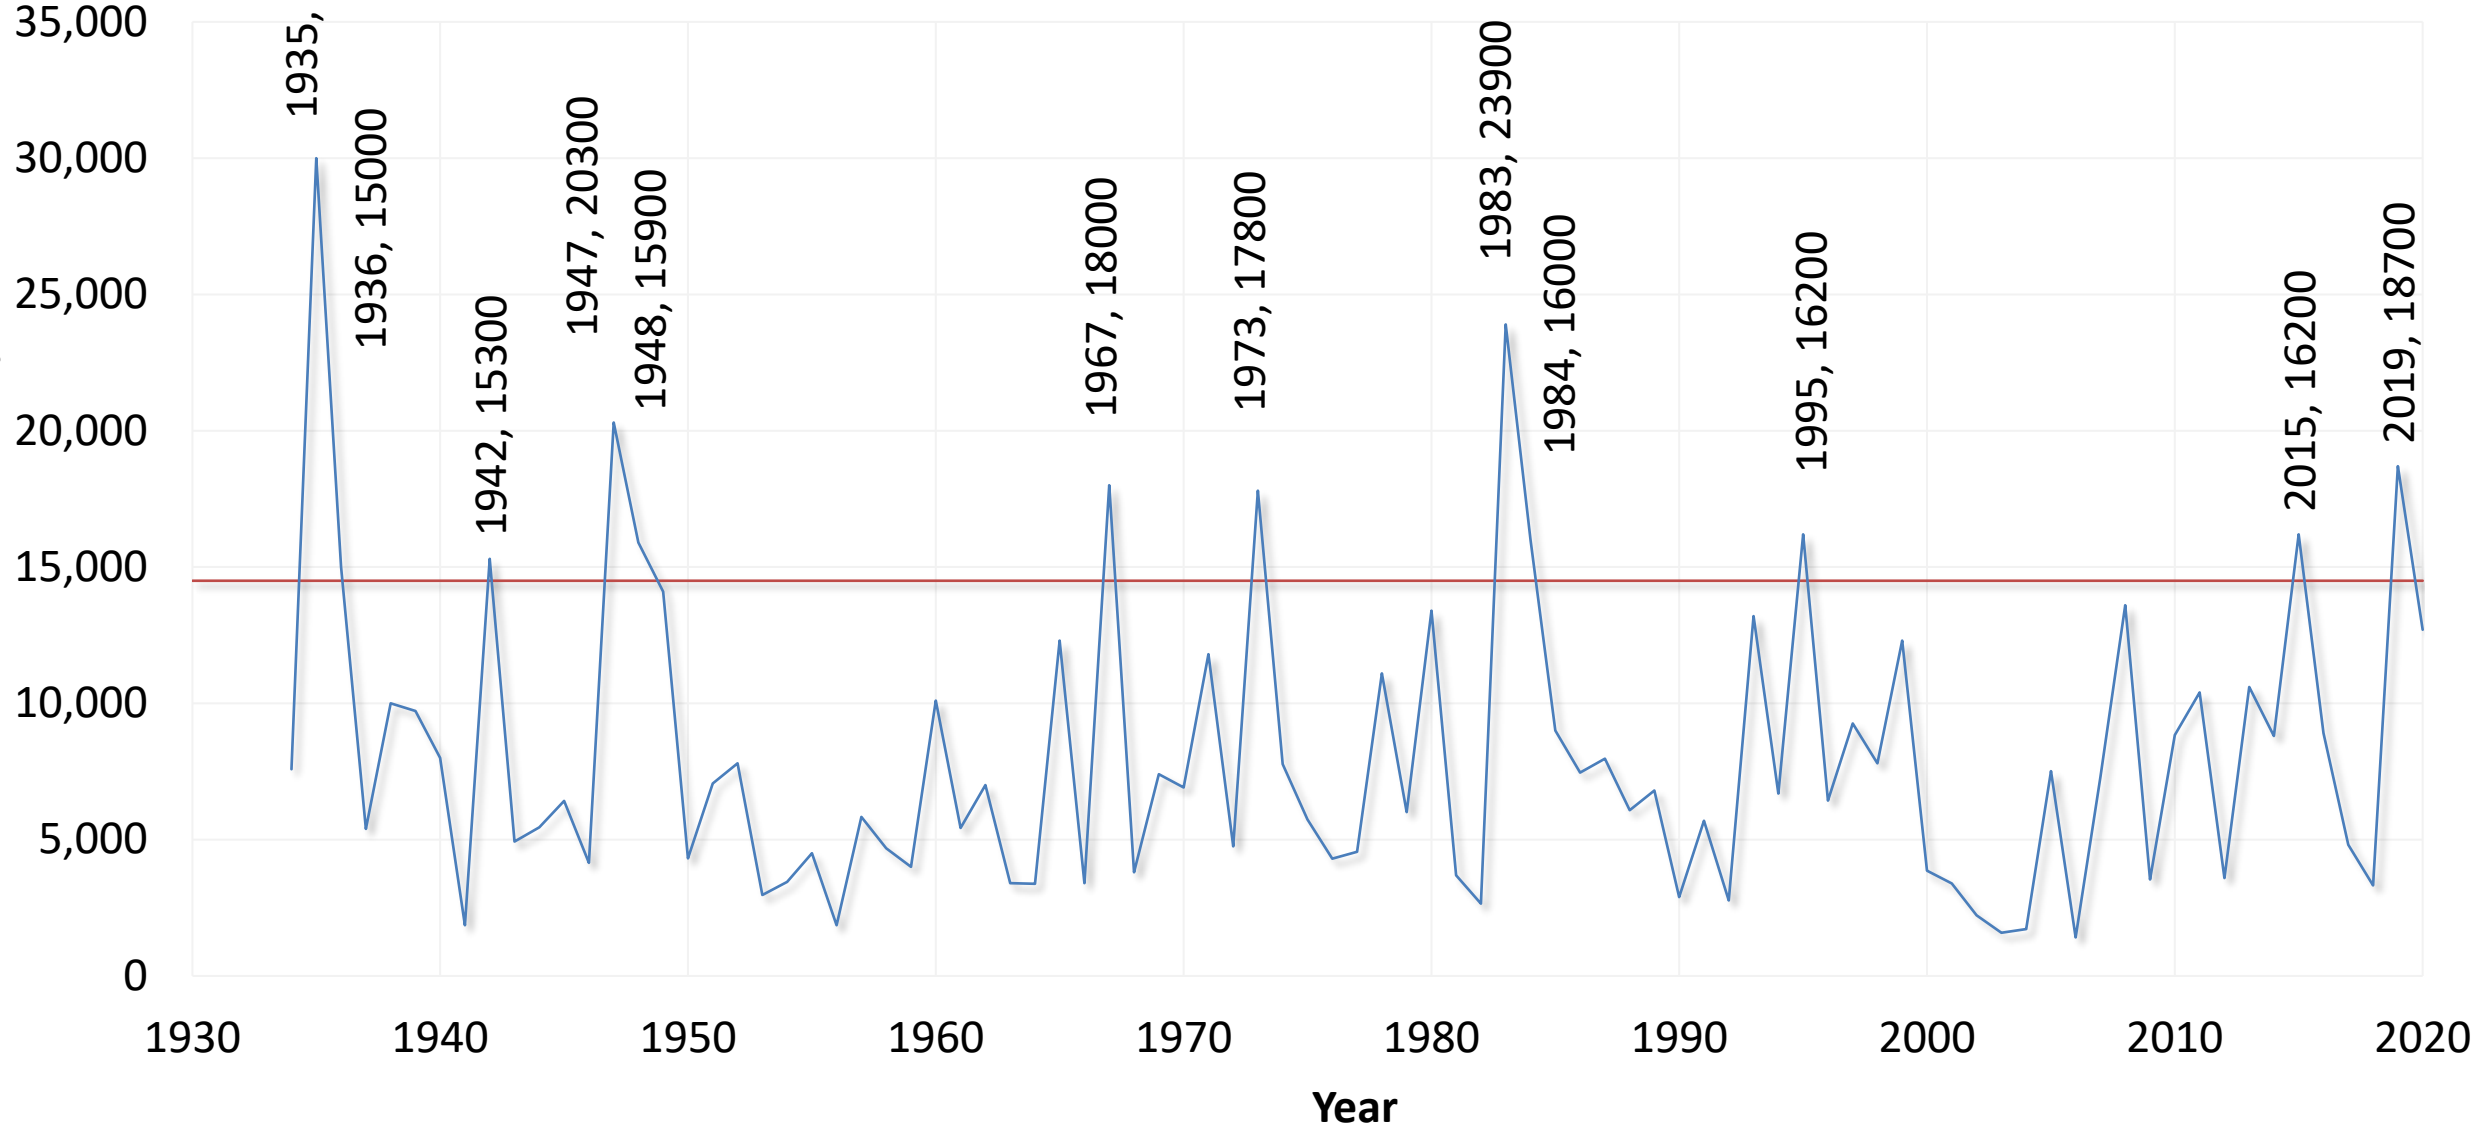
14,496 cfs (10 yr flow)

Annual peak flow

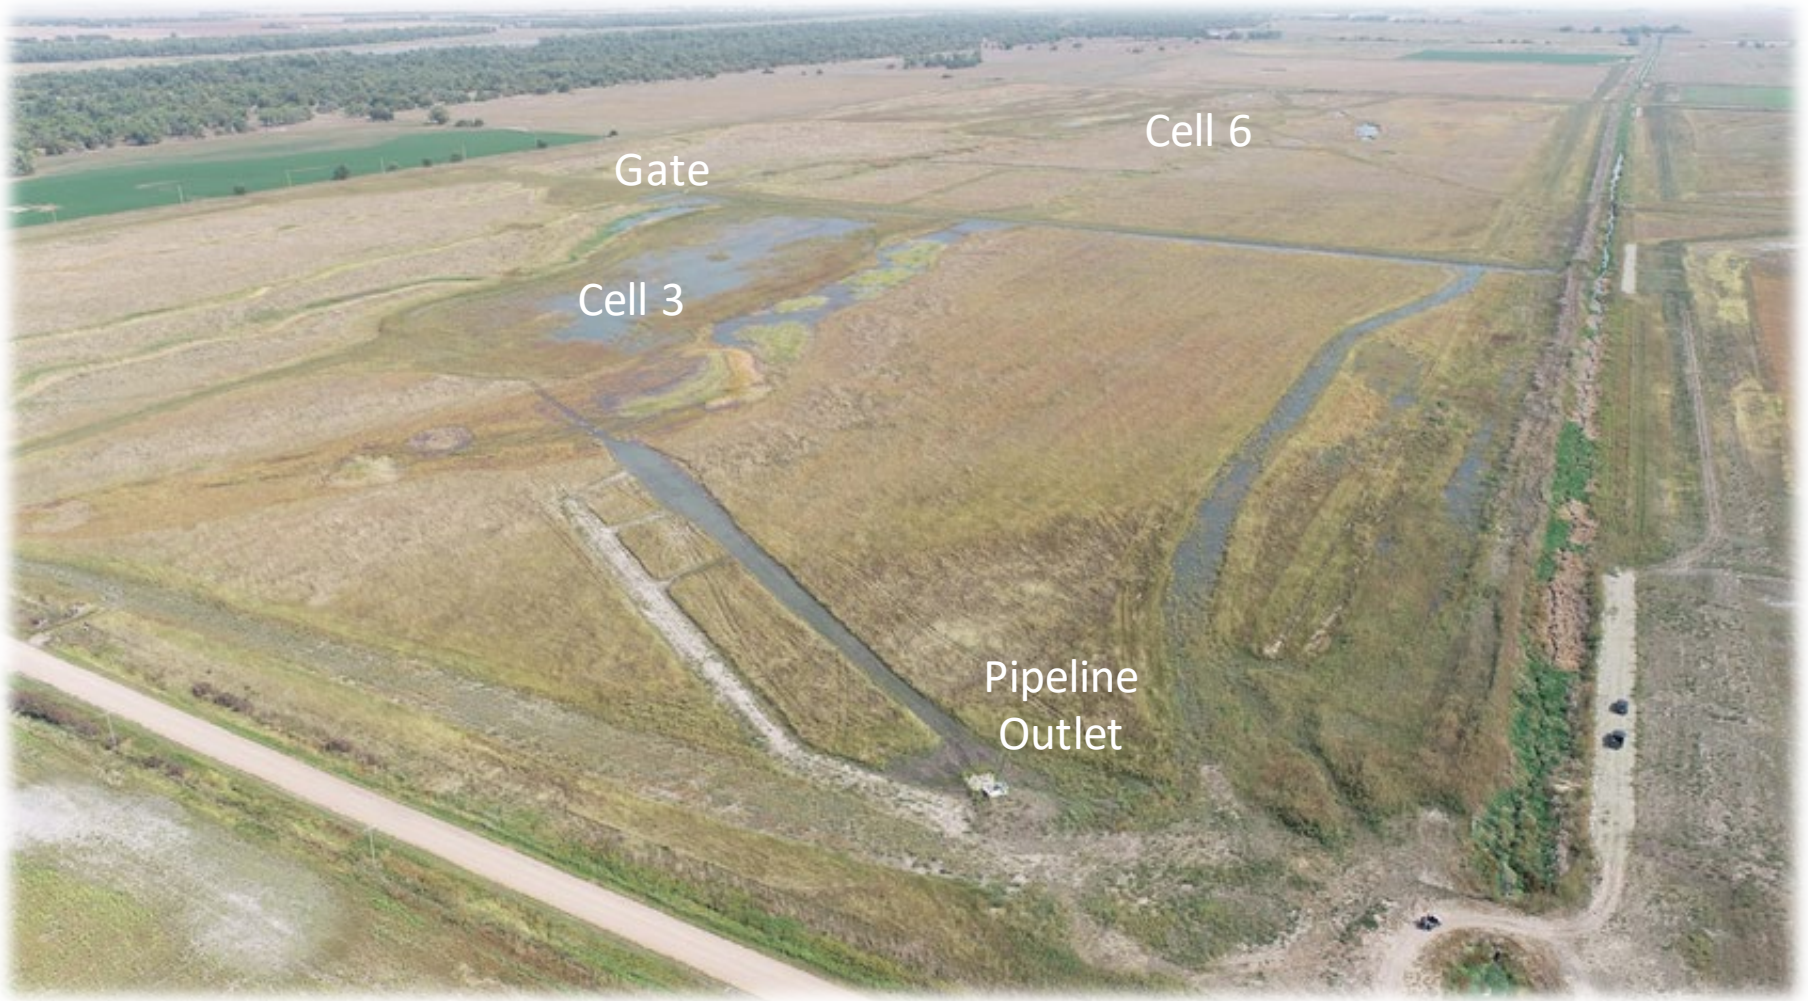
Gate

Cell 6

Cell 3

Pipeline
Outlet

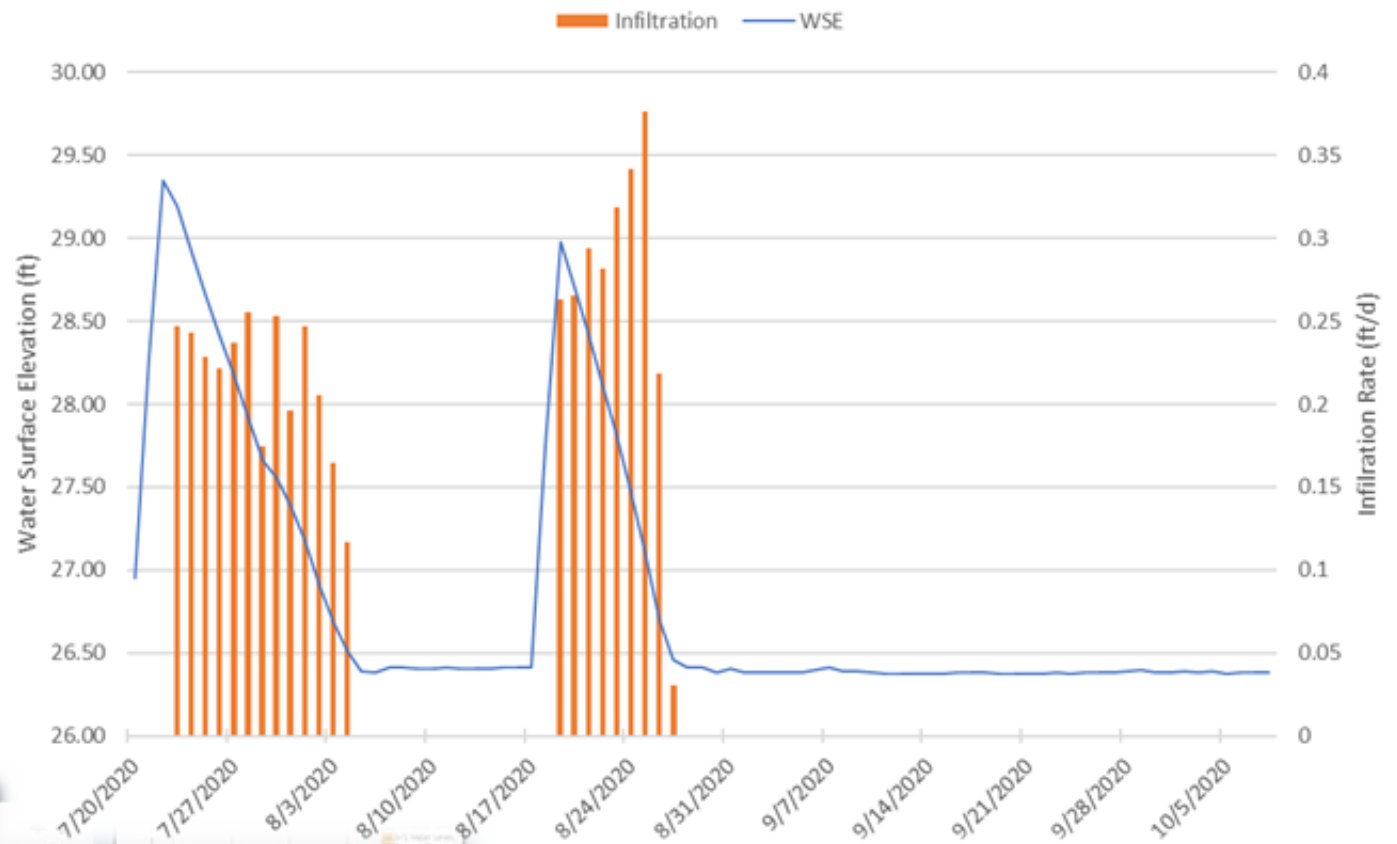
PRRIP GATE 1

Gate 1 Local-Remote **REMOTE**
RTU Software Version No. 6.0320
Operating Level 8.000ft

Communication Status	OK
Control Mode	POSITION
Gate 1 Position Setpoint	22.91 in
Gate 1 Position	22.91 in
US Water Level	26.383 ft
DS Water Level	26.380 ft
Current Flow	0.0 cfs
Current Volume for Season	153.8 AcreFt

Gate 1 Elevation	29.264 ft
Gate 1 Flow	0 cfs

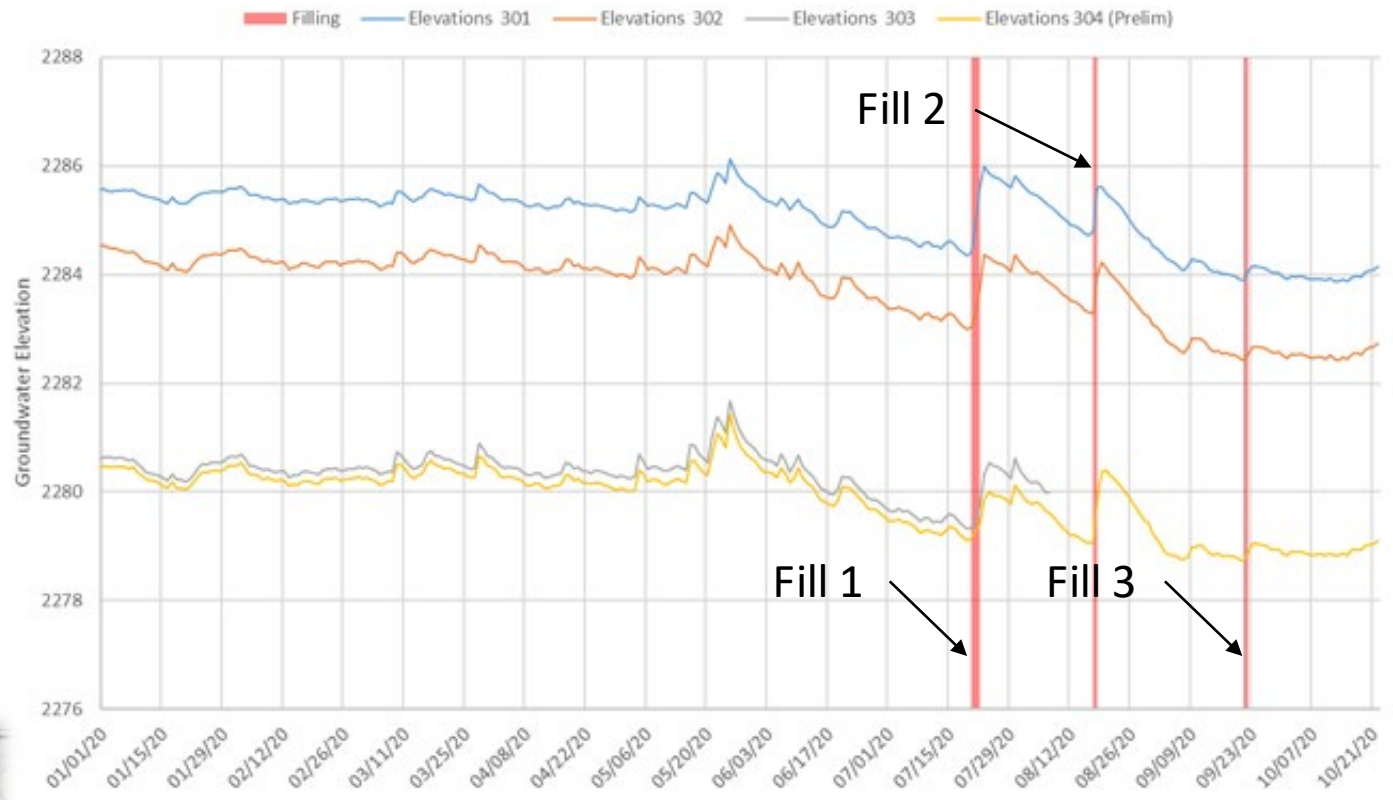
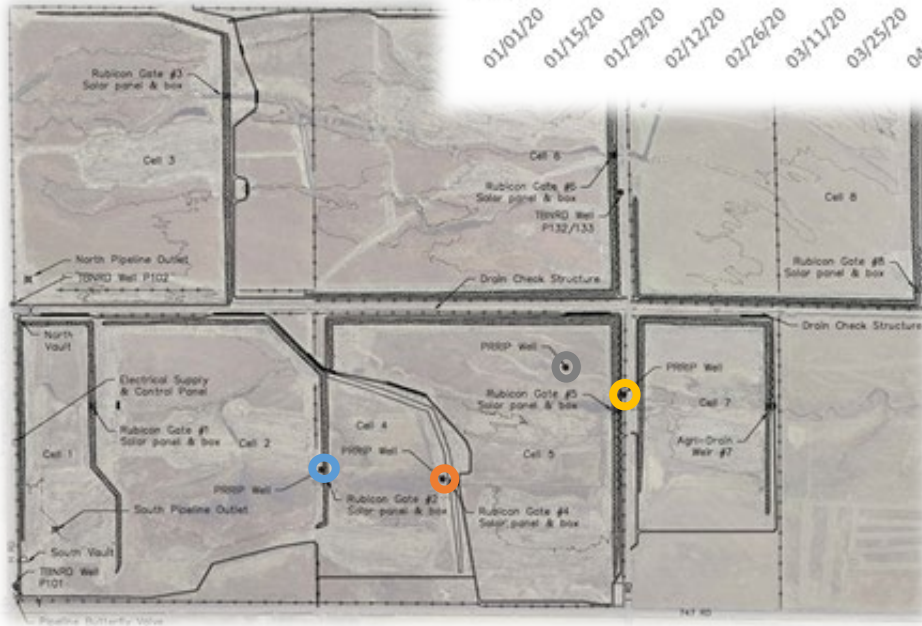
- Infiltration rates and other characteristics vary from cell to cell.
- Range is approximately <0.05 to 0.4 ft/day.

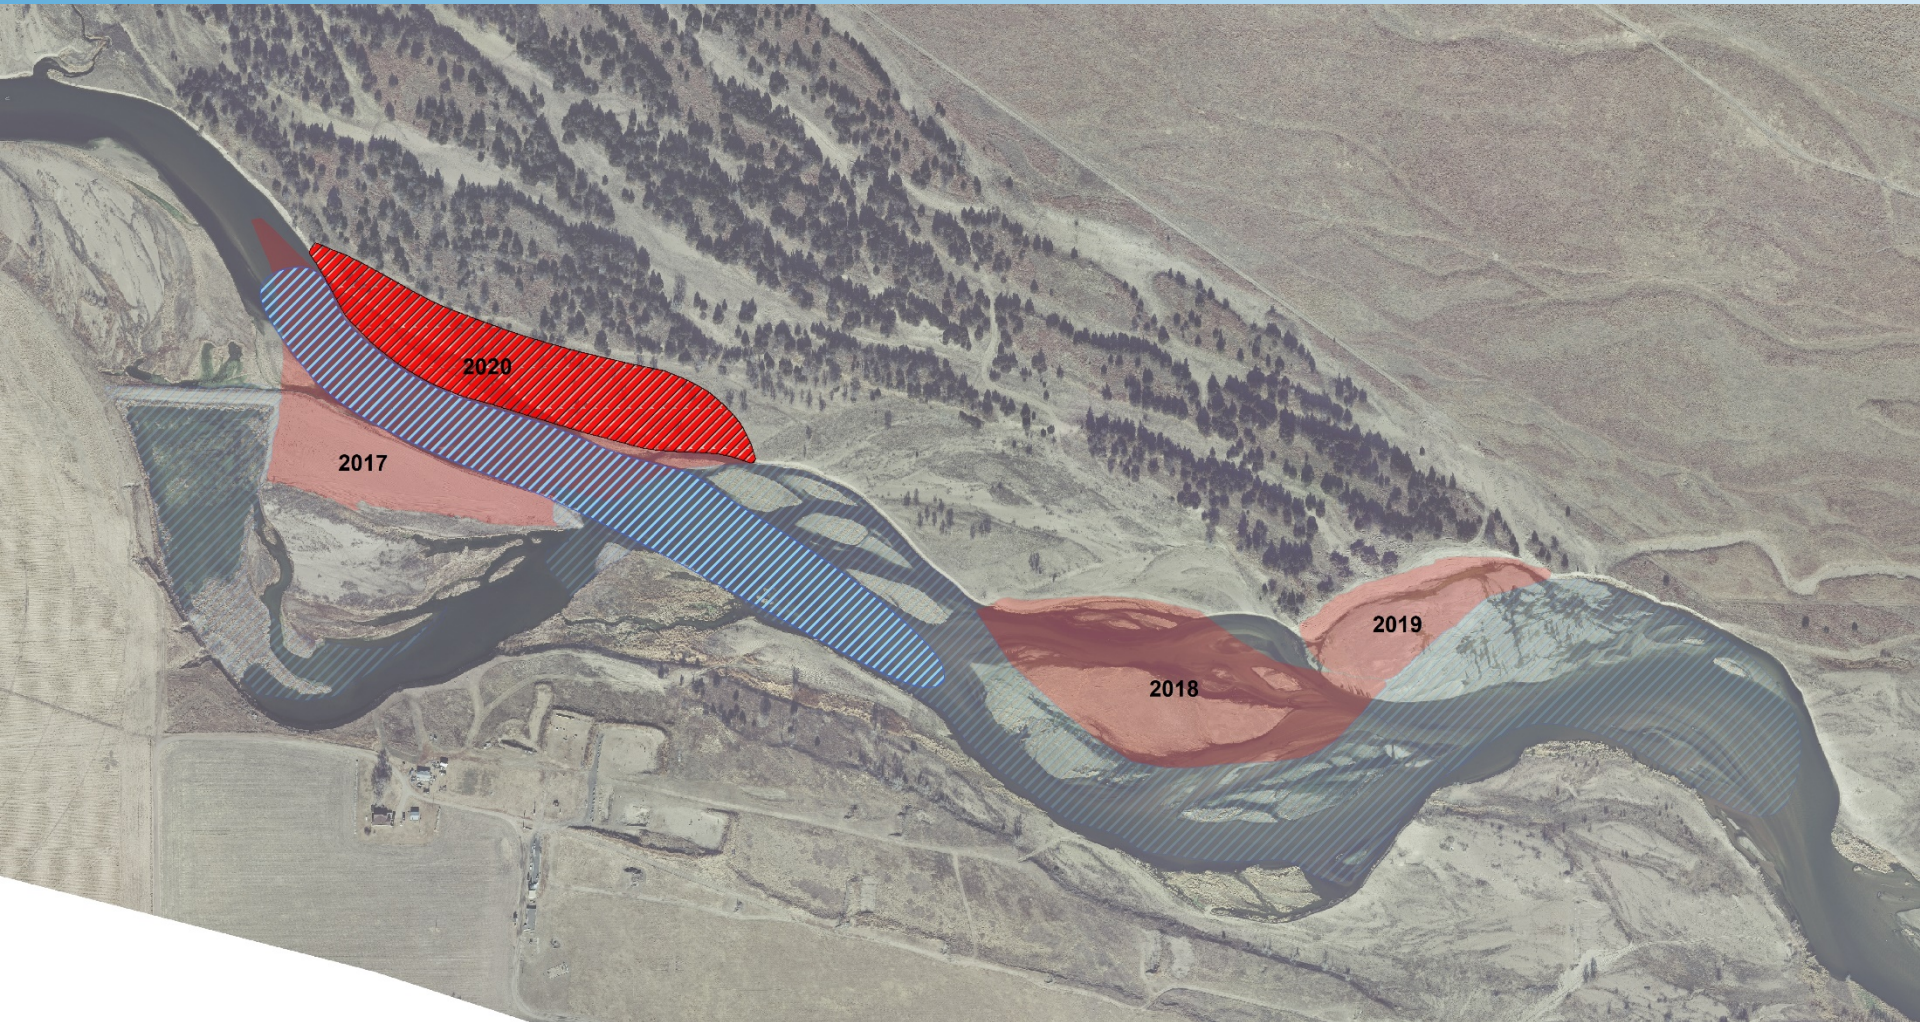
2020 Design Approach

(Permit for 60,000-80,000 tons/yr)

- Increase to 75,000 tons (49,300 CY)
- Move upstream and widen into high terrace.
- Arrest incision and knock down the energy.

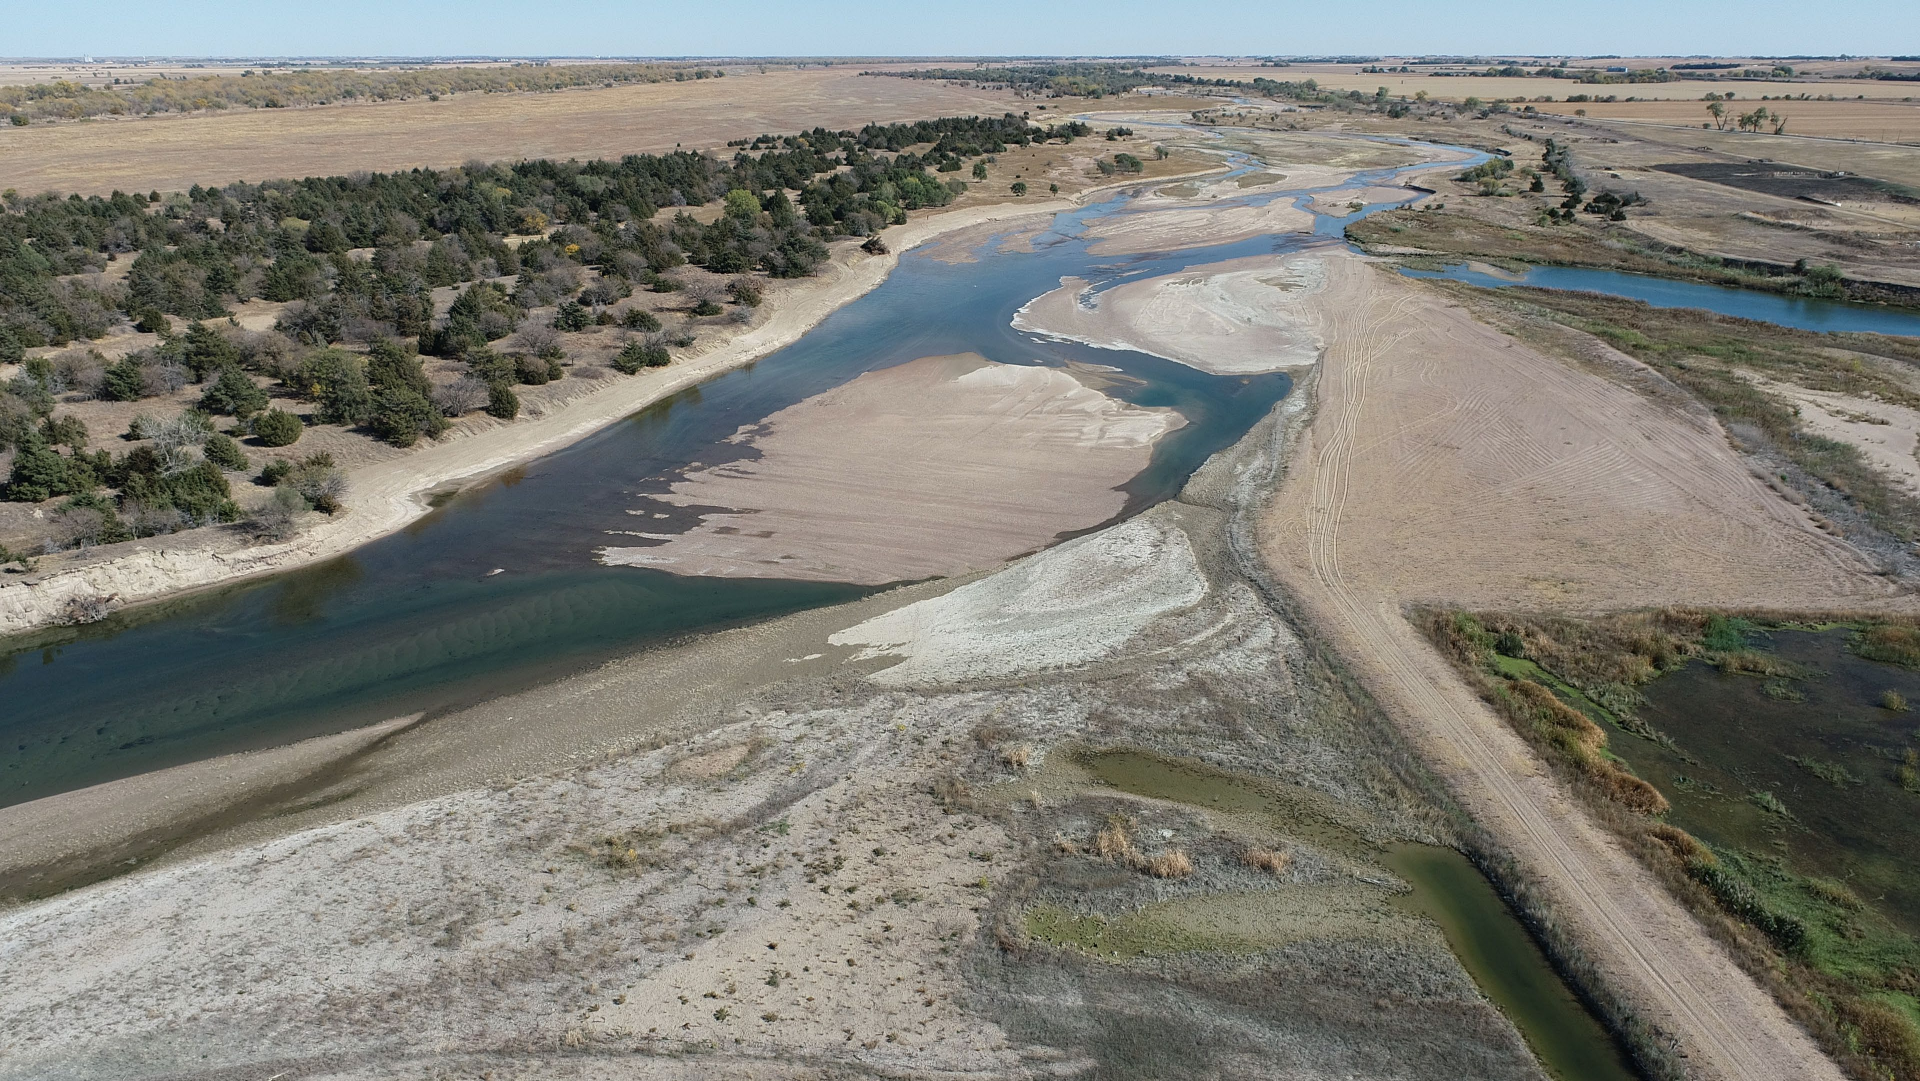
Post-Project 10/13

An aerial photograph of a river system characterized by extensive sandbars and meandering channels. The sandbars are light tan with visible ripple patterns, while the water channels are darker brown. Patches of green vegetation are scattered throughout the landscape, particularly along the riverbanks and in some of the larger sandbar areas. The overall scene depicts a dynamic fluvial environment.
