PLATTE RIVER RECOVERY IMPLEMENTATION PROGRAM

Least Tern and Piping Plover Monitoring Protocol Implementation Report for 2006

**Prepared by:
Executive Director's Office**

June 18, 2008

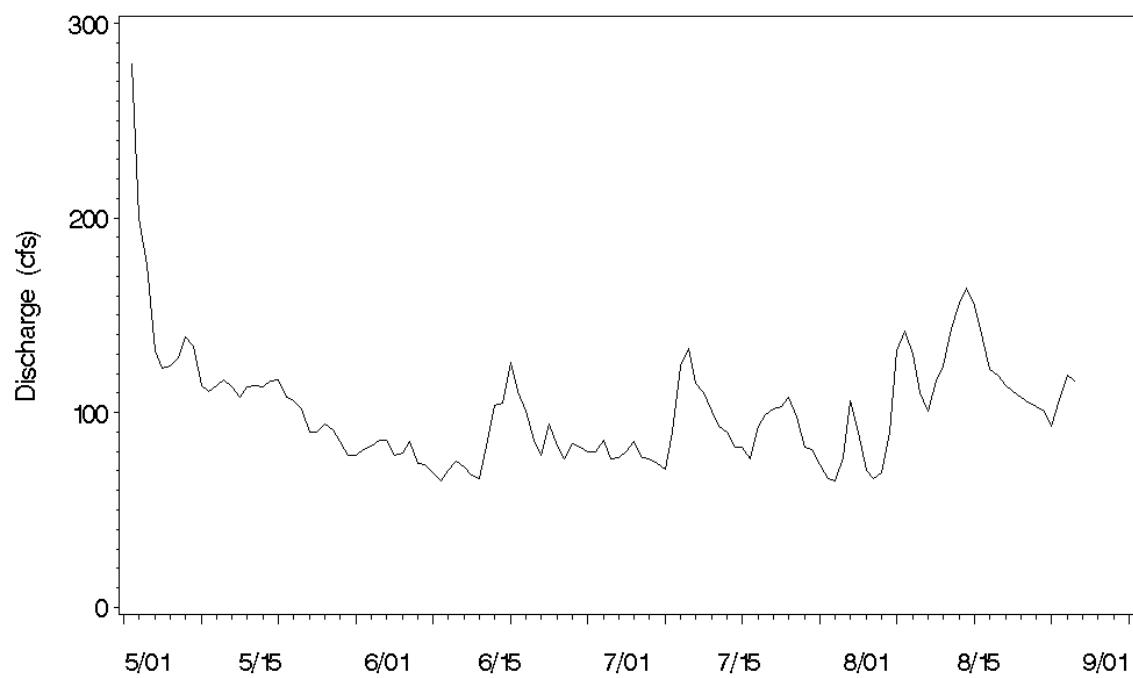
Figure 1. Discharge (cfs) at Overton, Nebraska (USGS Gage No. 06768000) from May 1 through August 31, 2006.

Surveys of the central Platte River were conducted in 2006 to locate active nests and individual birds (Component 1 of the protocol design). Surveys were conducted of all channels wider than 75m that could safely be navigated. Two airboats were used during the survey. Personnel from the Grand Island Field Office, U.S. Fish and Wildlife Service (USFWS) conducted the river survey from Chapman upstream to the Kearney Canal headgates (near Elm Creek) on May 17, 18 and 19. No surveys of this section of river were conducted in June or July due to low water conditions. Nebraska Public Power District (NPPD), Central Nebraska Public Power and Irrigation District (Central), and Central Platte Natural Resources District (CPNRD) personnel conducted the river survey from the Kearney Canal headgates upstream to Lexington on May 18, and June 6. No surveys of this section of river were conducted in July due to low water conditions. The lengths of river surveyed for each of the surveys are in Table 1. The daily average in-stream flows and stage levels for the Overton, Kearney and Grand Island gages during the river surveys are in Table 2 and during the months of May, June and July are in Figures 1-6.

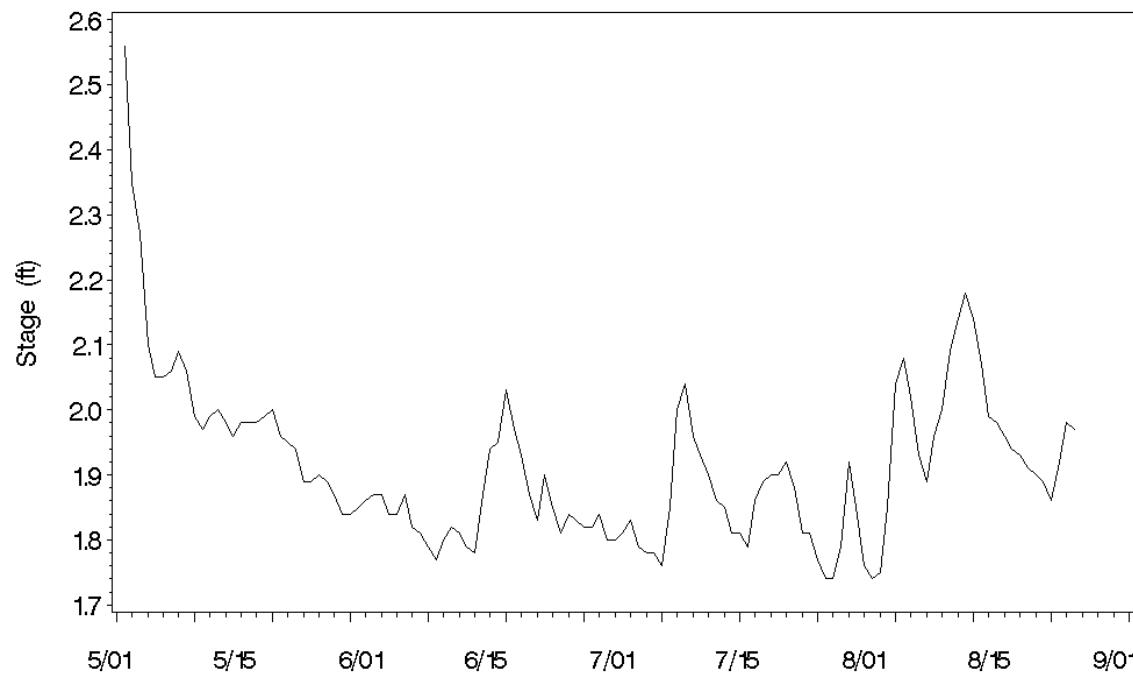
Figure 2. Stage (ft) at Overton, Nebraska (USGS Gage No. 06768000) from May 1 through August 31, 2006.

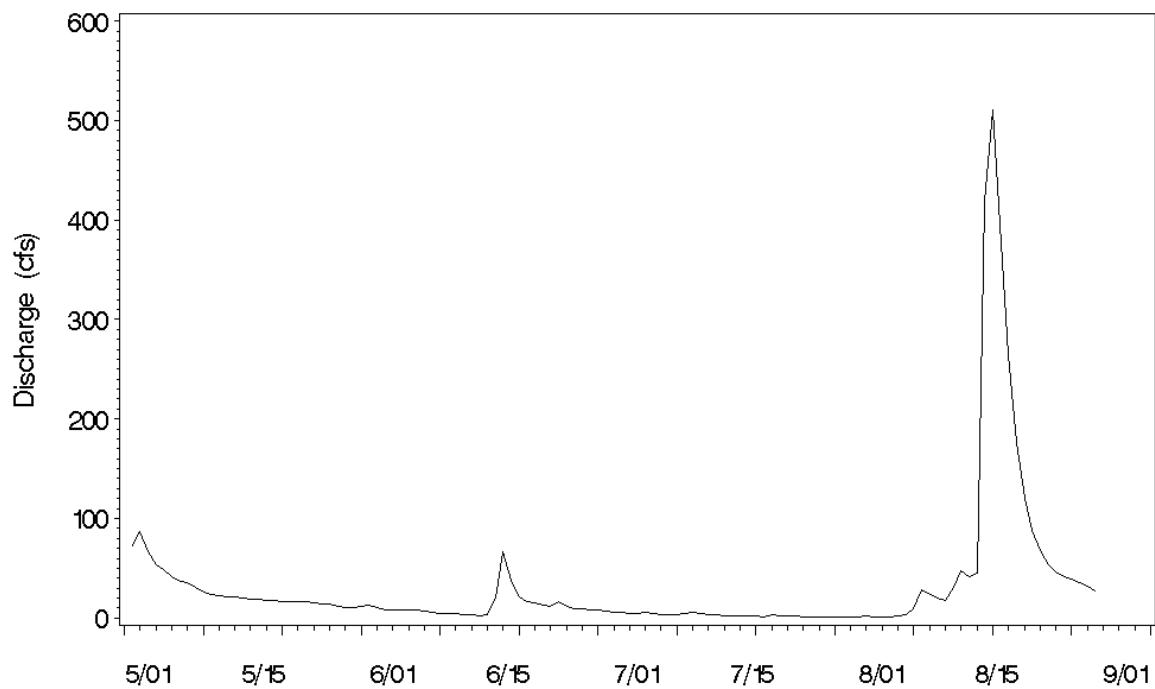
Figure 3. Discharge (cfs) at Kearney, Nebraska (USGS Gage No. 06770200) from May 1 through August 31, 2006.

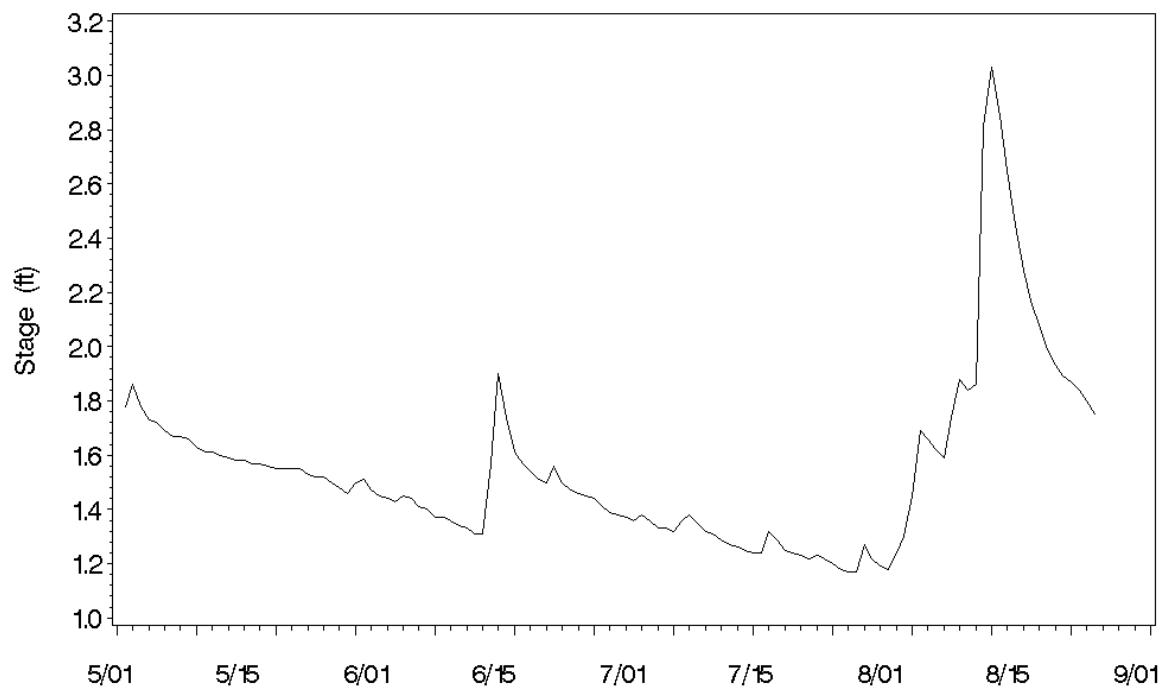
Figure 4. Stage (ft) at Kearney, Nebraska (USGS Gage No. 06770200) from May 1 through August 31, 2006.

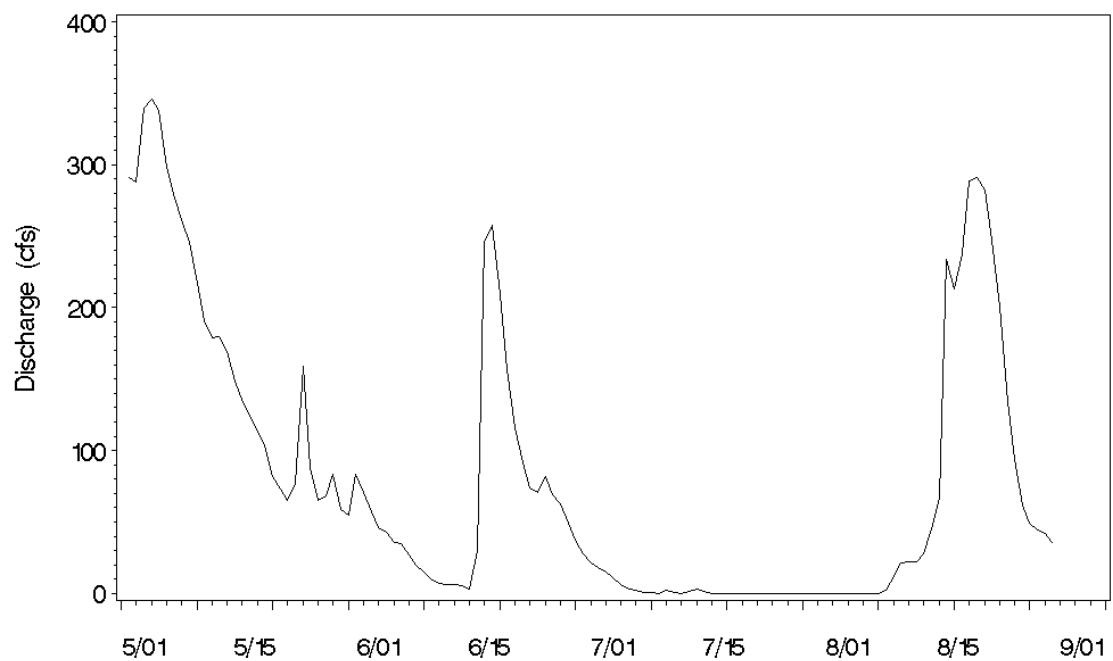
Figure 5. Discharge (cfs) at Grand Island, Nebraska (USGS Gage No. 06770500) from May 1 through August 31, 2006.

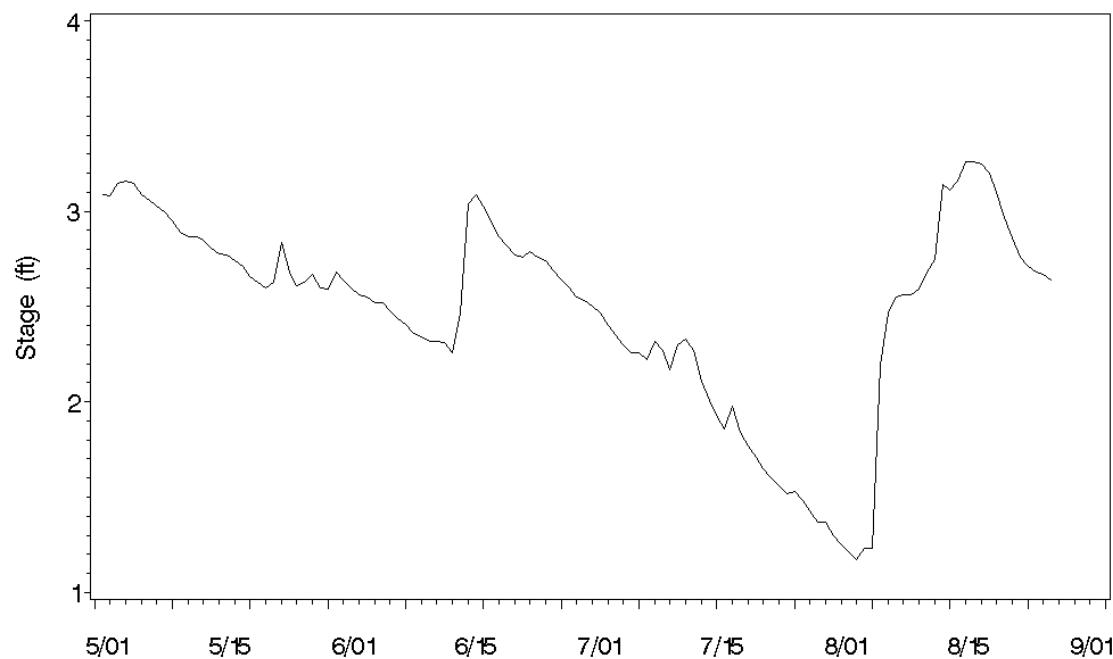
Figure 6. Stage (ft) at Grand Island, Nebraska (USGS Gage No. 06770500) from May 1 through August 31, 2006.

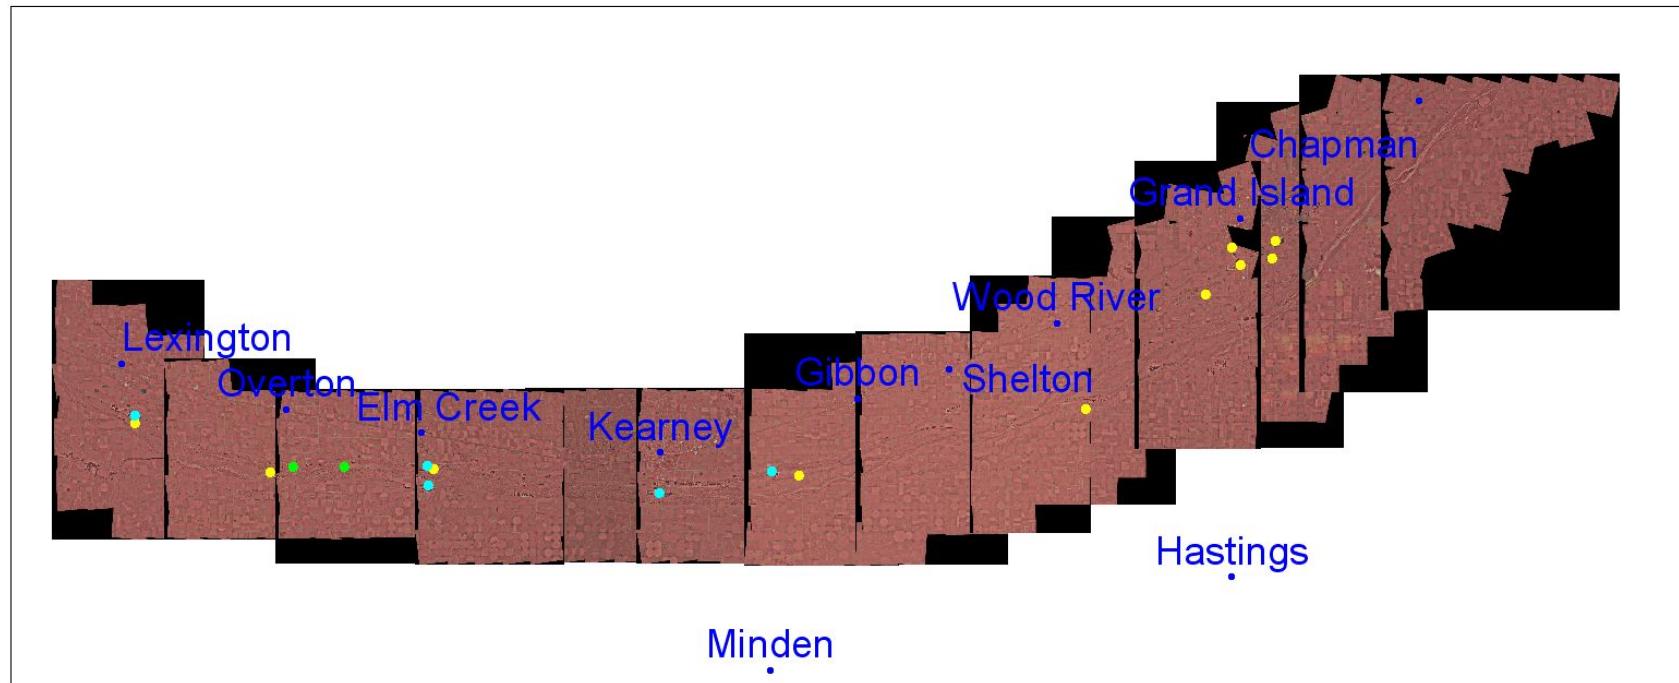
Figure 7. Sandpits and constructed islands surveyed for the 2006 season and locations of least tern sightings and nesting. Background image is the Fall 2003 color infrared photograph.

Least tern nests were located at 5, and piping plover nests were located at 6 of the 18 sandpits/constructed islands surveyed (Table 7; Figures 7 and 8). Three of these sites were monitored every three days while nests were active.

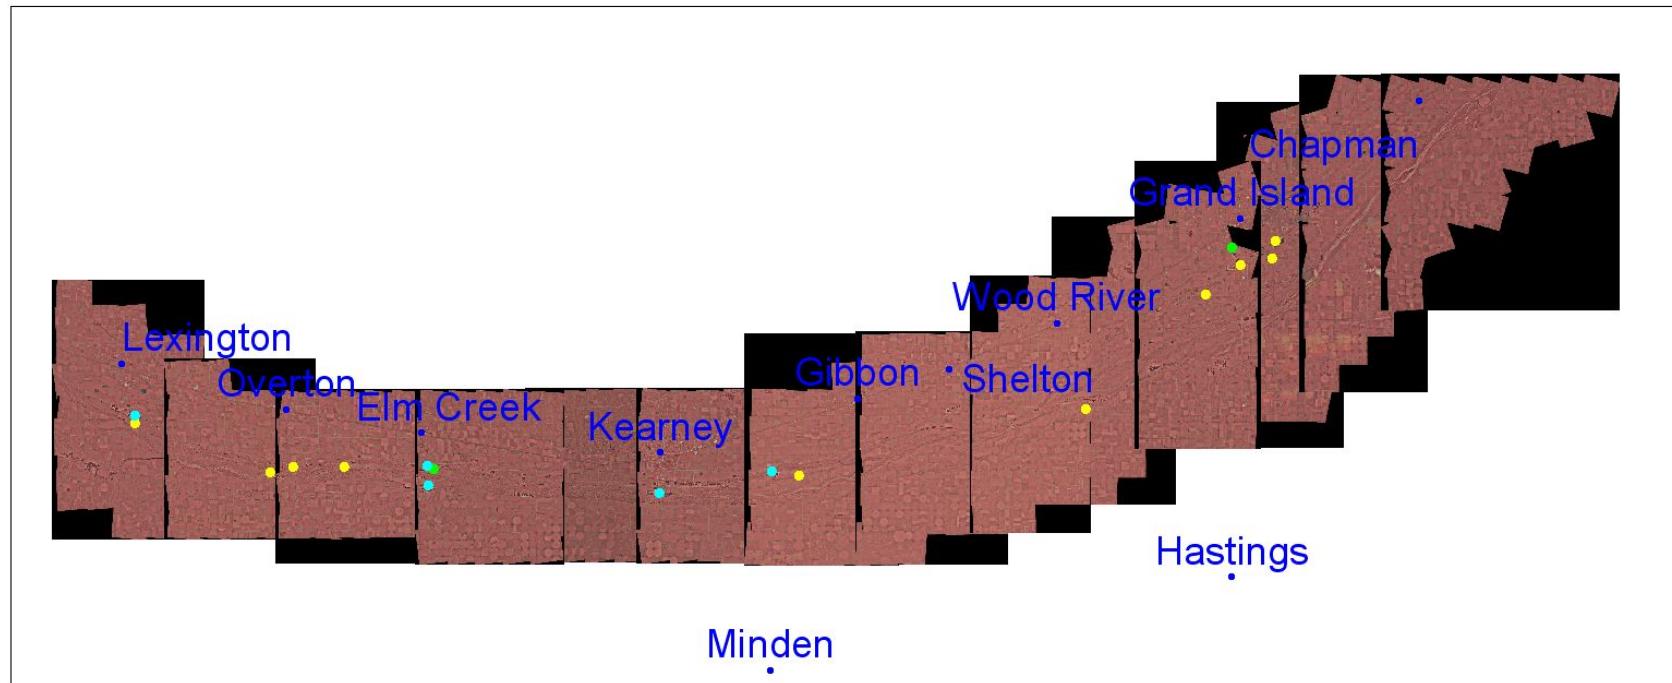
Figure 8. Sandpits and constructed islands surveyed for the 2006 season and locations of piping plover sightings and nesting. Background image is the Fall 2003 color infrared photograph.
